Repair of G4 Aircraft Heavily Damaged by Fire

Milutin Martinović, BSc (Eng)¹⁾

Extensive airframe and system damage caused by fire in oxygen installations on two Super Galeb G-4 aircraft is discussed in this paper. The assessment of the damage extent along with the damage inspection and repair possibility are also presented. Fixation of the fuselage structure to maintain the original geometry during repair is described. The repair project, the production of necessary tools and the structure repair realization with the final aircraft testing for the first after-repair flight are shown. Finally, an attempt to establish possible causes of fire is made.

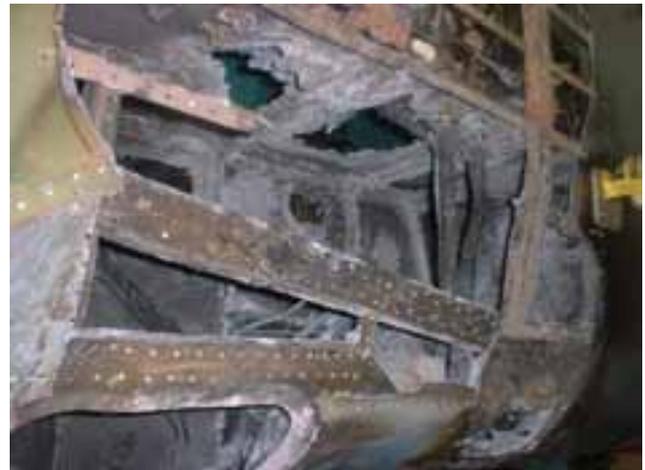
The type and extent of damage were of such proportions (Fig.1), that standard repair procedures and instructions were useless. It was necessary to comprehensively assess the extent of the damage and define an original repair project for each aircraft depending on the damage. Due to the seriousness of the damage on the load carrying structures and systems, it was decided that the project of repair [2] for both aircraft would be done by the VTI Aircraft Division while the UTVA Pancevo Aircraft Industry would carry out the repair of structures and systems. In order to reduce costs to the minimum, it was

Figure 1. Damaged structure after the fire

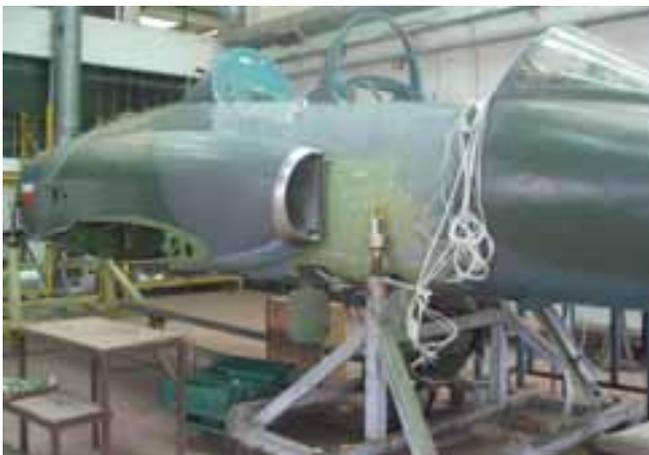
Aircraft mounting had to be solved before the beginning of damage detection and repairs. The first aircraft was placed on the JIG with four cranes for hoisting the aircraft at fuselage frames No.10 and No.26, as shown in Fig.2. This JIG was formerly used during the G-4 serial production. It was not possible to implement the same procedure to the second aircraft, since the whole section of joints for hoisting the aircraft at the starboard of frame No.10 was destroyed and had to be reconstructed.

Figure 2. Mounting assembly for the first aircraft

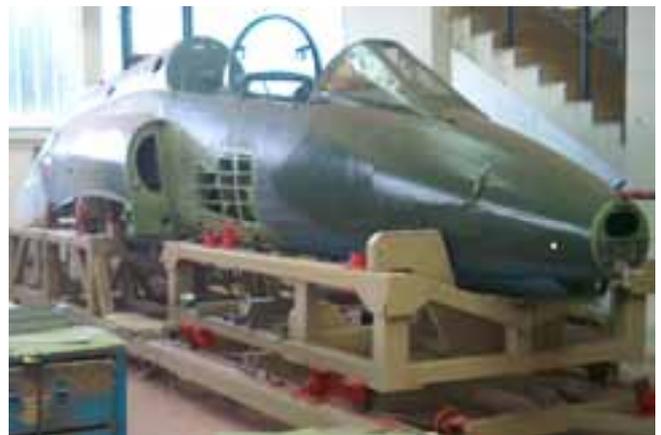
For the mounting of the second aircraft an assembling JIG (haling) was used, shown in Fig.3, the same assembly structure that was used during the aircraft production for the assembly of the cockpit section and the fuselage central section. This tool was modified in order to reduce static loads of the aircraft during repair. The aircraft was connected to the tool at frames Nos.5 and 21, which was a relatively wide range for an aircraft as damaged as this one, since 50 percent of the fuselage cross-section was missing. To prevent bending and twisting of the fuselage during repair, new mounts were added to the tool at the position of No.10 frame, both left and right ones. The left mount was used during the whole period of repair, whereas the right one was just a temporary solution, since its role was taken over by a permanent mount at the position of frame No.8. This assembly tool provided a high quality repair with full comfort.

Figure 3. Assembly tool for aircraft mounting

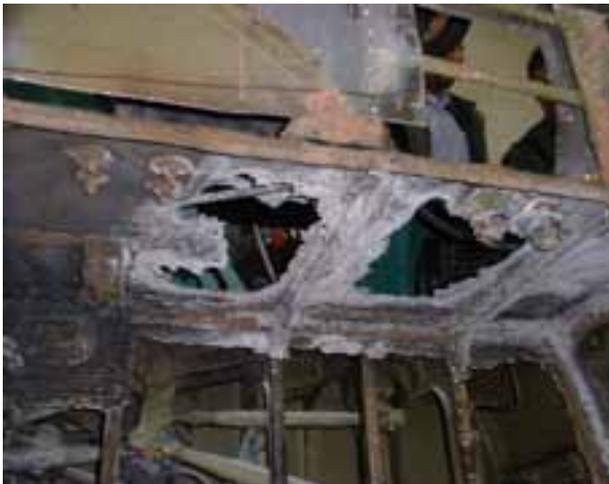
Heat effects on the structure caused total burnout of duralumin, melting, bending, wrinkling, and change in material structure. A characteristic duralumin aircraft structure exposed to high temperatures is shown in Fig.4.

Figure 4. Burnt duralumin structure

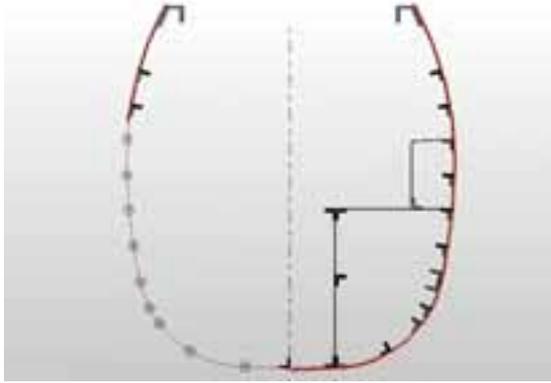
fuselage structure, after the fire, is shown in Fig.5. It is evident that the fire damaged approximately 50% of the structure.

Figure 5. Undamaged fuselage structure in the zone of fire (bolded)

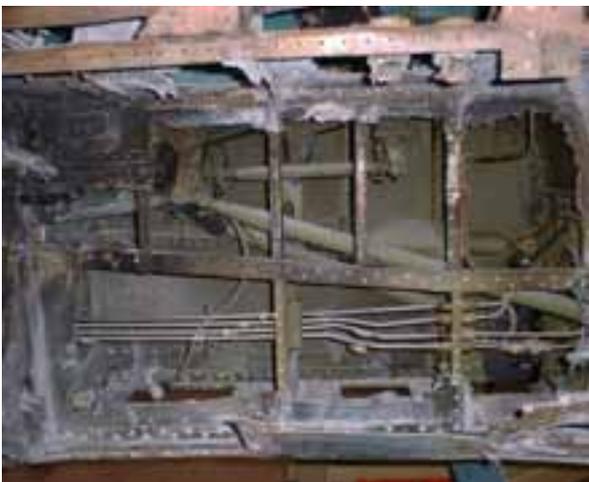
The extent of the damaged structures was 1500 mm in length, 900 mm in height and 650 mm in width. Some damaged and partially cleaned basic structure parts are shown in Figures 6 and 7.

Figure 6. Partially cleaned aircraft after the fire

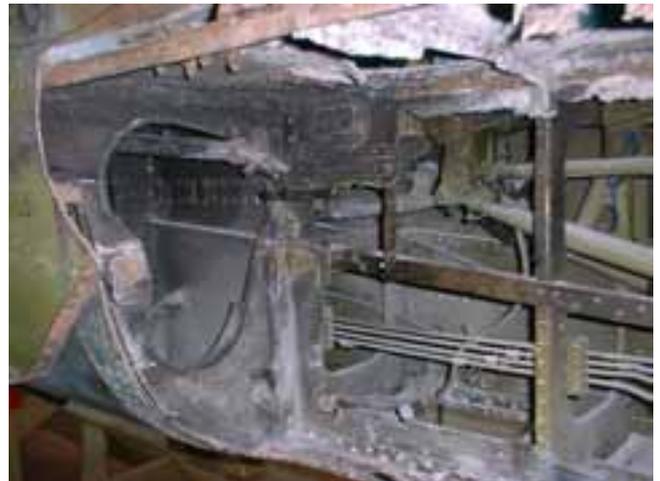
Figure 7. Damaged structure after the fire

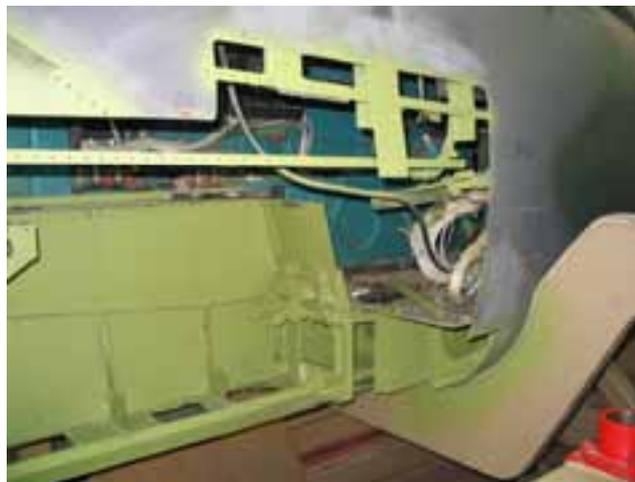
Figure 8. Prepared structure for the integration of elements

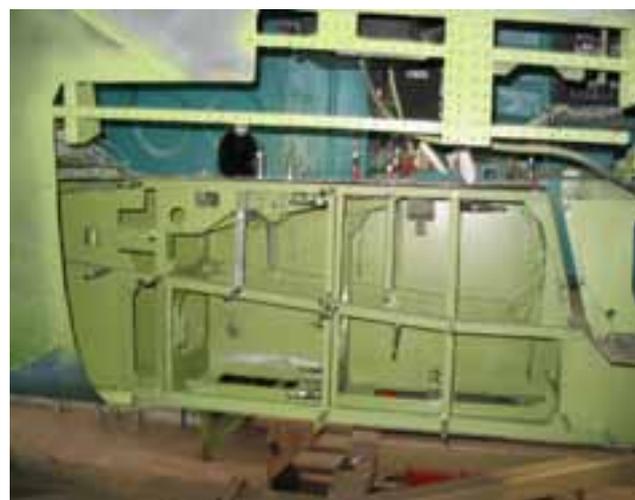
Figure 9. Forming of the keel structure

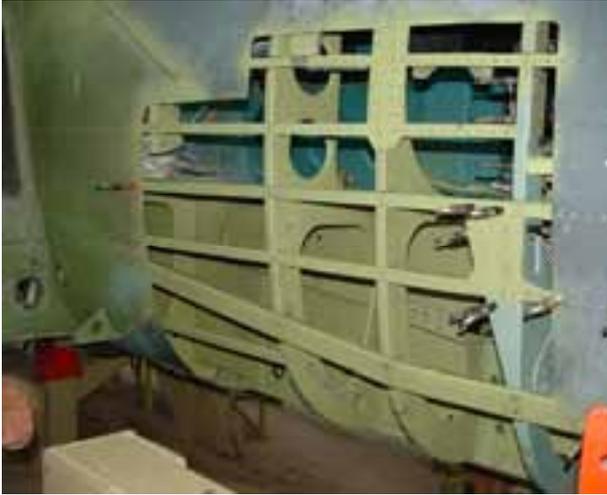
Figure 10. New formed fuselage structure

strict tolerances. Separating riveted elements of the structure and disassembling had to be done very carefully, since it was imperative not to widen holes of connecting elements. The elements to be built into the structure were supplied with required additions in order to be compatible with the aircraft structure. The port wall of the keel (Figures 8 and 9), was first assembled and then the starboard wall. The new keel was thus formed as a compact unit. In the keel interior, mounts for the control stick and other control commands were installed. The next phase included the assembly of new ribs and their connection with the existing structure. The net of stringers was then formed (Fig.10) and joined with the existed ones. The method used allowed for

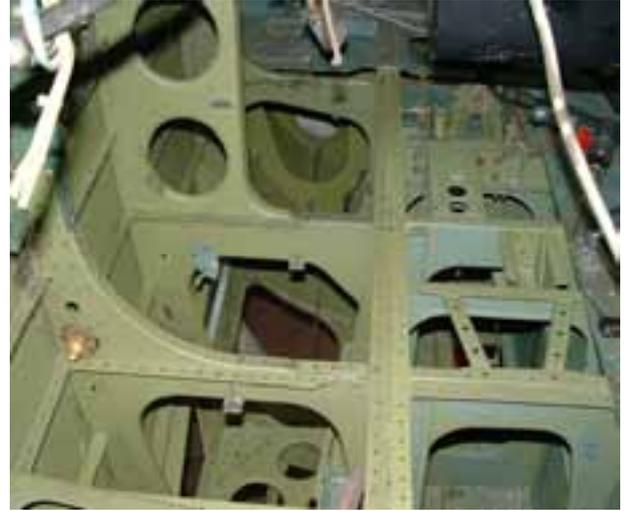
Figure 11. New formed structure of the second cockpit

forming highly compact fuselage structure as a whole (Figures 10 and 11). The next phase was the assembly of the skin panels (Fig.12) and the cockpit floor and their final installation. As many parts of skin and floor were damaged and it was necessary to join and bridge several dozens of structural elements, the problem of hermetization of cockpit space emerged. Because of that, adequate procedures had to be foreseen to realize efficient sealing. Since the producer did not have the cockpit at his disposal, the test of hermetization had to be conducted only after the aircraft assembly in the air base. PRC polymerized mixture was used for hermetization. This mixture was applied to each contact surface between two elements as well as to upper parts of all connecting elements, as recommended by SNO 4604 Standard. The complex structural repairs were successfully performed, with high quality, by the UTVA Pančevo AI. These repairs are shown on a series of photos taken during the repair.

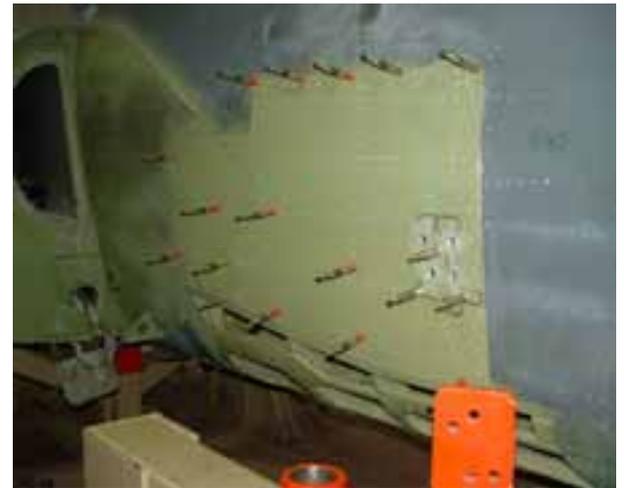
Figure 12. Precise integration of a skin panel on the side of the second cockpit

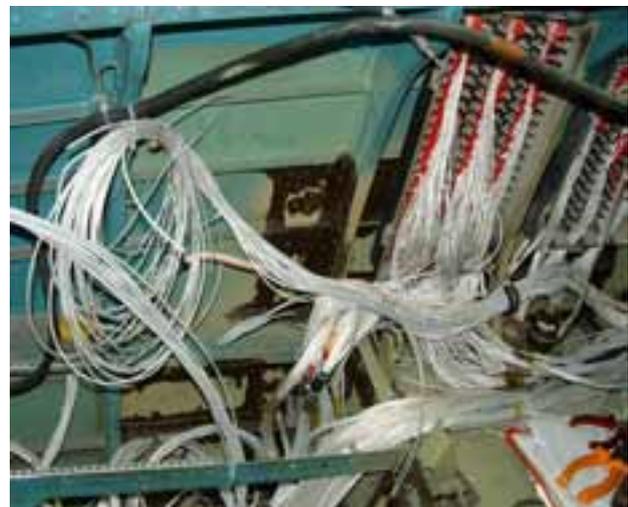
Figure 13. Wiring installation into the cockpit sides.

Major difficulty was to install cables, since almost all of them were damaged by fire, and they had to be replaced in full. All cables from the front fuselage section were replaced. Bundles of wires with connectors were formed on workbenches and then built in, which was very difficult due to many hardly accessible zones. Complexity of this task could be seen in Fig.13. After the installation of cables,

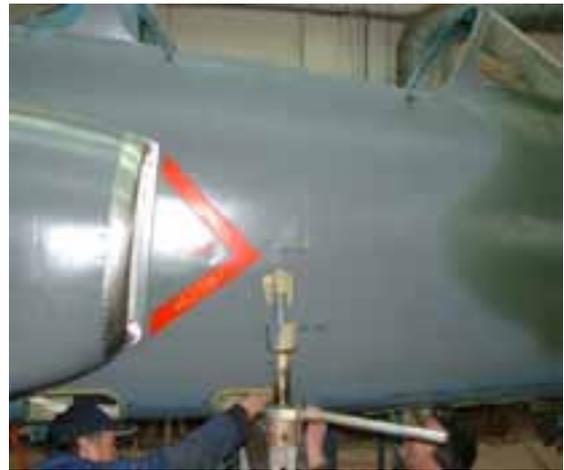
Figure 14. Aircraft at the end of structural repairs
