Moisture Mapping of Aeronautical Museum Depot and Galleries by IR Thermography

The paper presents the results of moisture detection in the depot and galleries of the Aeronautical Museum in Belgrade. The moisture and changeable temperature conditions are the main causes for corrosion in historical buildings and museum artefacts. The main purpose of the tests was to determine these conditions in the museum where very important metal artefacts are exhibited and deposited, including the only surviving example of the Fiat G50 aircraft, by applying passive IR thermography. The advantages of thermography in a rapid and accurate detection of moisture in the walls, ceilings and floors of the museum are analysed. Active IR thermography is used for the determination of the composite structure and the characterisation of hidden corrosion in some parts of the Fiat G50 aircraft. The recorded thermograms indicate the damage due to corrosion in many parts examined in detail by radiography and the XRD method.

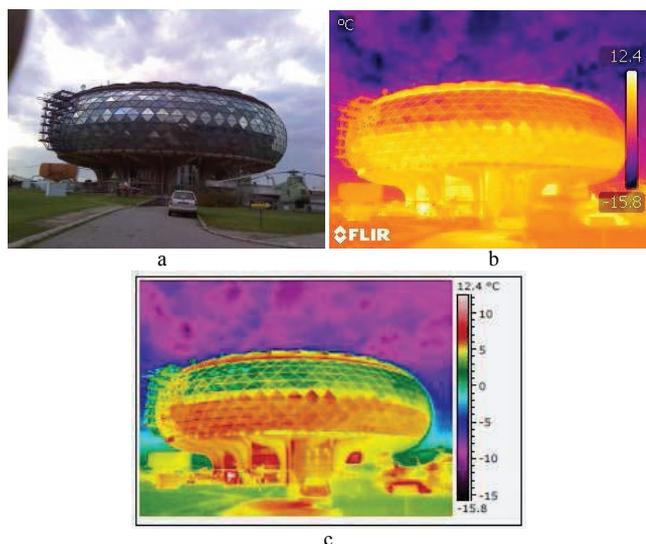
Figure 1. Aeronautical museum building in Belgrade, a - photo, b- thermogram in iron palette and c - thermogram in rainbow palette

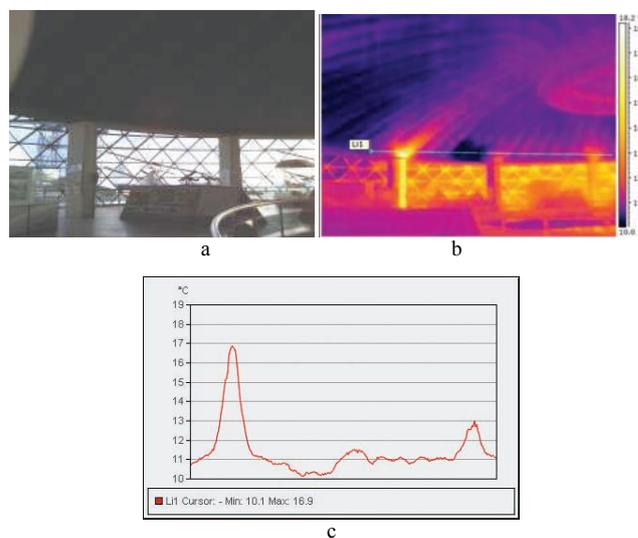
the temperature along the line shown in Fig.2b. The line includes both the hot and the cold zone. The temperature difference is over 10°C (Fig.2c). The zone with active moisture has the temperature of about 1°C lower than the surroundings temperature. The darker area between the first and the second pillar is the place where the atmospheric water penetrates inside. The presence of water inside the walls can be considered as one of the most important causes of degradation in buildings. The evaporation flux from the wall surfaces can be estimated quantitatively by measuring the surface temperature since it depends on the evaporation rate. The value of the surface temperature, in equilibrium conditions for all different heat exchange contributions to the wall, depends on the evaporation rate, material thermal conductivity as well as temperature and ventilation experimental conditions.

Inside the museum dome, the brighter, warmer areas present the penetration of warmer air from the lower part of the museum through the technical tunnels (Fig.2b).

Figure 2. A part of the museum gallery, a - photo, b - thermogram of this part and c - temperature change diagram along the line

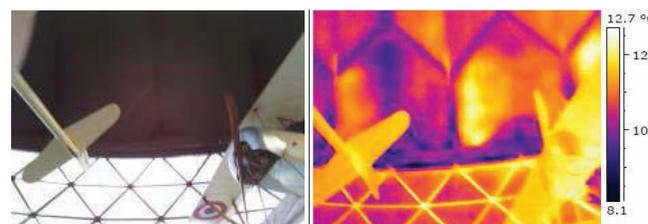
Figure 3. Details of the ceiling, the temperature oscillations recorded on the roof construction are the results of poor thermo insulation

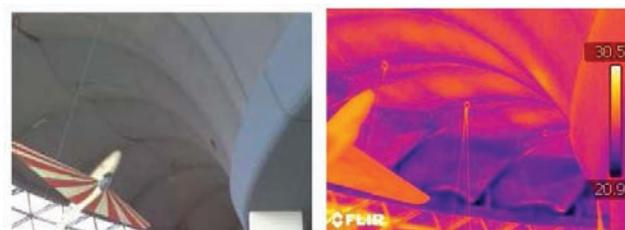
Figure 4. Photo and the thermogram of the gallery dome

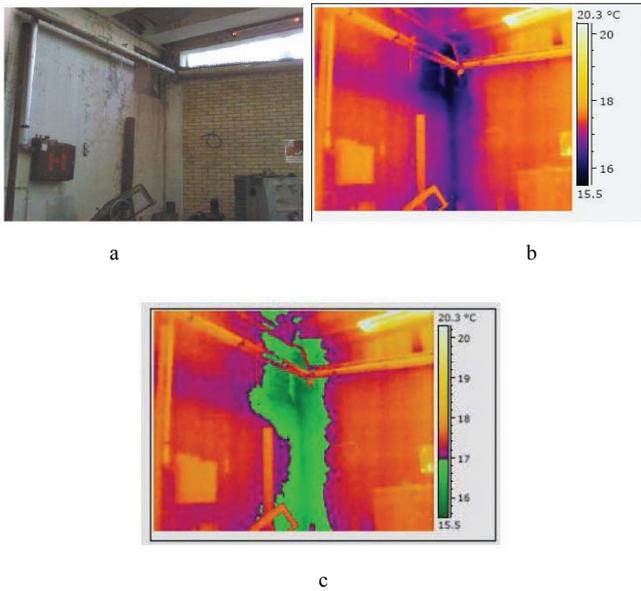
Figure 5. a - Photo and b - thermal images of one corner in the museum depot, c - wet area obtained by isotherms

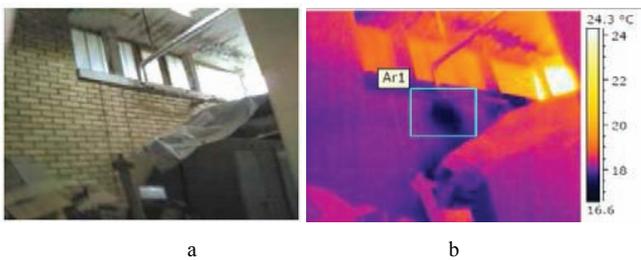
The photo (Fig.6) confirms that there is a stain on the wall below the windows, on the right side, (Fig.6a) and IR thermography shows that there is active moisture (Fig.6b). The moisture area is colder and appears as a darker area on the thermogram. On the other, left wall, (Fig.7) the stain is not visible, (Fig.7a), but the thermogram shows that there is moisture (Fig.7b).

Figure 6. The stain and moisture area below the windows on the right

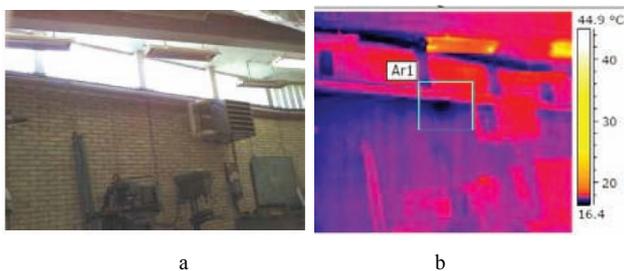
Figure 7. The wall below the windows without a stain, but with captured moisture (Ar1).

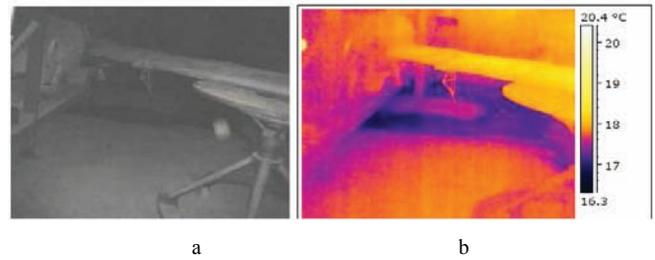
The presence of moisture is found in several places in the floor of the depot (Fig.8), on the ceiling and the walls (Figures 9 and 10b). The thermogram 9b next to the line tool has the area limited by isotherms. The diagram in Fig.9c shows that the temperature difference along the line tool is more than 1°C (1.3°C). The similar temperature distribution is on the line tool, Fig.10.

Figure 8. Moisture is found in several places in the floor of the depot

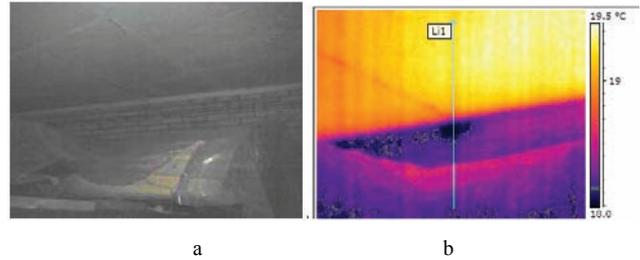
Figure 9. a - Photo record, b - thermogram and c - temperature diagram of moisture in the upper wall part.

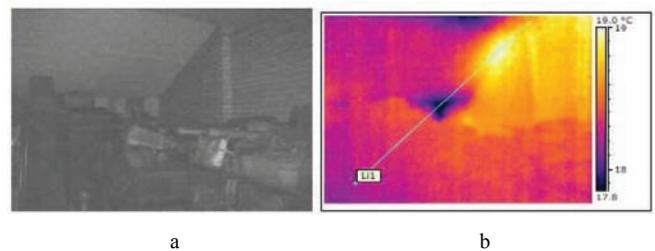
Figure10. Documentation for the detected moisture in the farthest right corner of the depot.

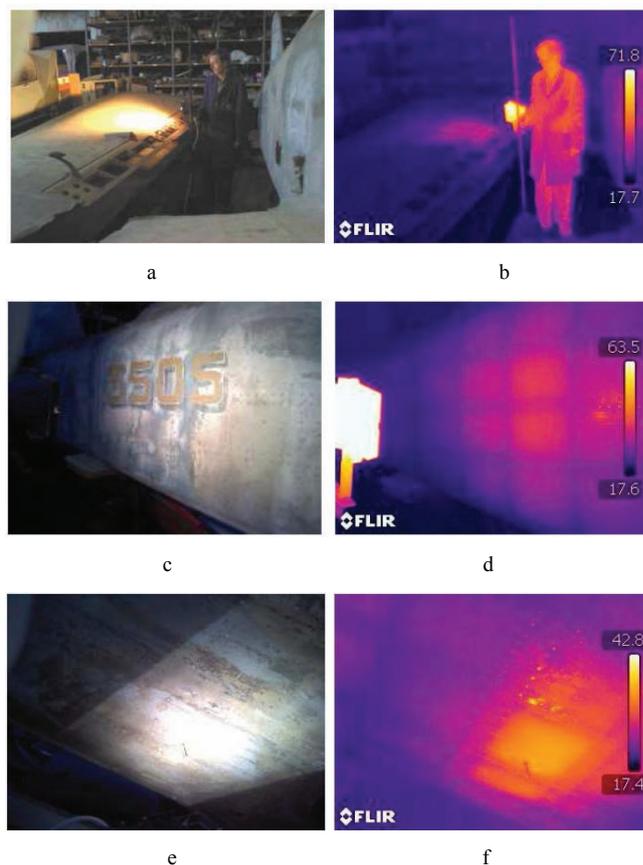
The thermographic inspection of the G50 aircraft was performed by the step heating technique. The increase of the surface temperature was monitored during the application of stepped heating. Some parts of the aircraft were continuously heated at low power. The variations of the surface temperature with time are related to the specimen features. This technique of step heating is sometimes referred to as time-resolved infrared radiometry. The time-resolved part means the temperature is monitored as it evolves during and after the heating process. Step heating finds various applications such as for coating thickness evaluation (including multilayered coatings, integrity of the coating-substrate bond, determination or evaluation of composite structures, characterization of airframe and hidden corrosion among others. Figures 11 and 12 show some parts of the aircraft thermographic inspection. The thermogram recorded the maximum temperature differences at the end of heating. The corroded parts have different temperatures compared to non corroded ones, because they have a porous structure and the corrosion products have different temperature conductivity and capacity in relation to the non corroded parts.

The recorded thermograms indicated the corrosion damage in many parts that were examined in detail by radiography and the XRD method. Fig.13 represents a radiogram of the aircraft landing gear. The composition of the corrosion products was analyzed by the method of diffraction of X-rays (XRD) and is presented in Fig.14 [4,17,18].

Figure 11. Thermographic inspection of the F50 aircraft; a, b - aircraft wing, c, d - side part of the aircraft and e, f - bottom side of the aircraft

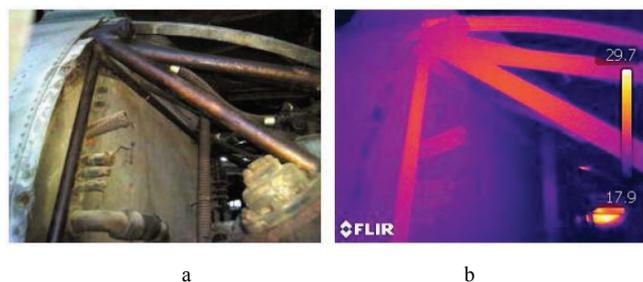
Figure 12. a - Photo and b - thermogram of a metal tube

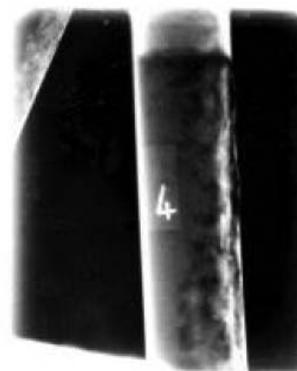
Figure 13. Radiogram of the F50 aircraft landing gear

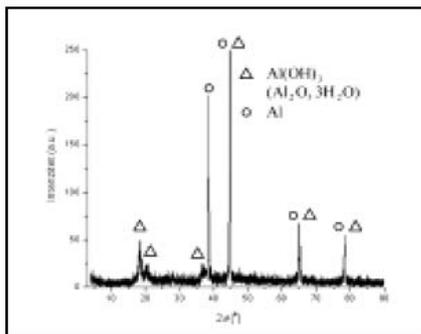
The sample base is aluminium, Al (JCPDS 4-0787). Crystal hydroxide aluminium, gibbsite, $\text{Al}(\text{OH})_3$, $(\text{Al}_2\text{O}_3 \cdot 3\text{H}_2\text{O})$ (JCPDS 70-2038) is detected in the corrosion products. The composition of the aluminium corrosion products analyzed by the method of XRD is presented in

Figure 14. The composition of the F50 aircraft corrosion products analyzed by XRD
