The Aircraft Structural Elements Corrosion Study Using Strain Gauge Method and Pulse Video Thermography

Ljubiša Tomić¹⁾
Dalibor Jovanović²⁾
Stevan Jovičić²⁾
Radovan Karkalić³⁾
Goran Dikić³⁾

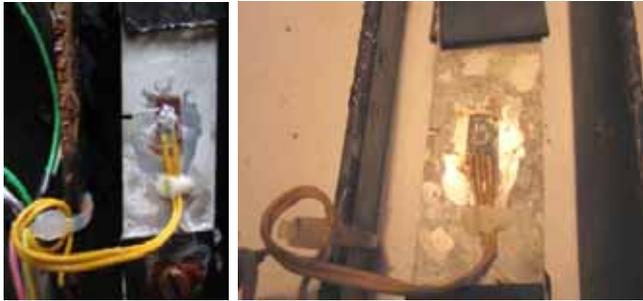
In the course of the exposure to the influence of salt fog, out of 7 tested samples which were in the salt fog chamber (the bars marked with numbers 2 – 7, 9), there were failures of strain gauges on seven bars (Fig.3).

Figure 3. Damage at strain gauges after the exposure to the influence of salt fog

The failures occurred due to the degradation of the protective characteristics of lacquer layer, by which the strain gauges were coated at the beginning of testing. Only the strain gauge on the test bar No.3 remained functional, as well as the strain gauges on the test bars 1 and 8, which were outside the chamber in room conditions.

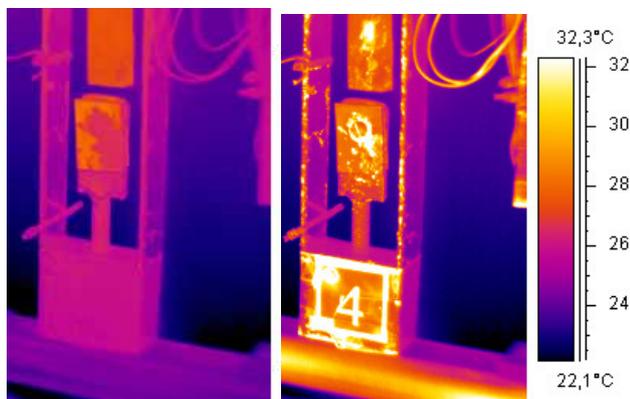
Fig.6 shows the thermograms of the 5th and 7th frame of the recorded NEW0098.SEQ sequence of the test sample No.4, cracking on the point of connection due to the stress corrosion. The left image shows thermogram before irradiation with the light impulse, while the right image shows the same sample after irradiation. The surfaces affected by corrosion are visible on the right image.

Figure 6. Thermograms of the test sample No.4, cracking on the point of connection due to the stress corrosion

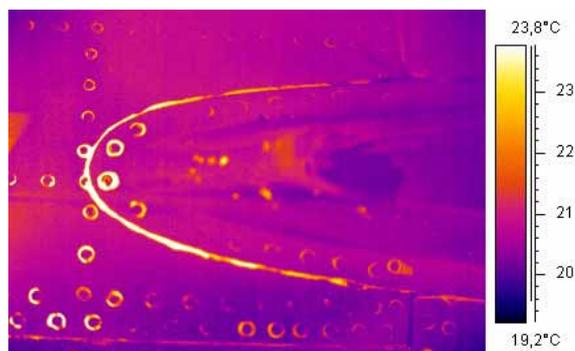
Fig.8 shows a frame of the recorded sequence after the use of flash light BW-3955 on the tailpane-fuselage fillet at the root of the tailplane. The warmer areas around the rivets where the corrosion process separated the paint from the basic material structure are clearly visible when the PVT method is used.

Figure 8. Thermogram of the 16th frame of the recorded sequence NEW0168.SEQ after the use of halogen lamp

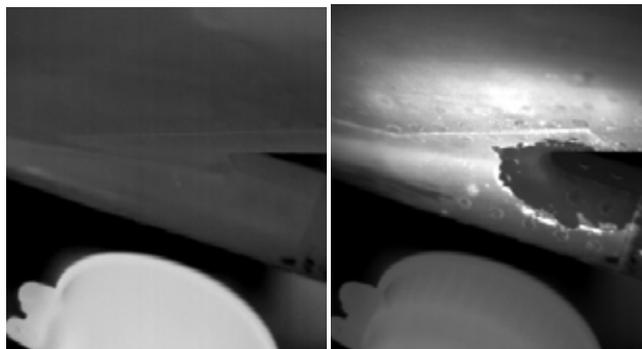
Fig.9 shows two frames of the damage of surface protection at the point of connection between the counter weight and tailplane due to the influence of corrosion.

Figure 9. Thermogram, the damage of surface protection caused by the influence of corrosion

The left image shows the surface before irradiation with the light impulse, it can be seen that pixel temperature of the surface is approximately uniform and within the noise limits (the image is given at the level of gray where warmer places are lighter). On the right picture the same surface is shown after irradiation with the light impulse.

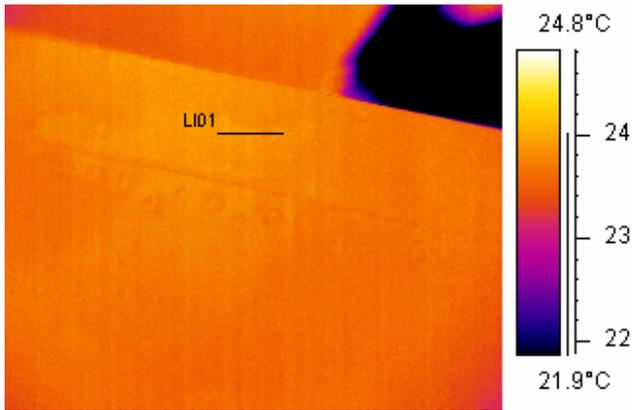
Fig.10 shows 17th frame in the recorded sequence NEW0134.SEQ before irradiation of the surface treated with light impulse. The surface of the part of the aircraft lining tested by the PVT method for subsurface corrosion. Rear frame at the structure of aircraft fuselage is made of steel, previously prepared, sanded and coated with protective paint. However, there has been a reforming of subsurface corrosion beneath the layer of paint due to inadequate and incomplete removal of corrosion. It is possible to observe in the picture the places where the sheet lining was riveted below the measuring line of pixels where the pixel temperature is LI01. The average pixel temperature along this line is 23.9 °C.

Figure 10. Thermogram of 17th frame, exit edges of tailplane surface before irradiation

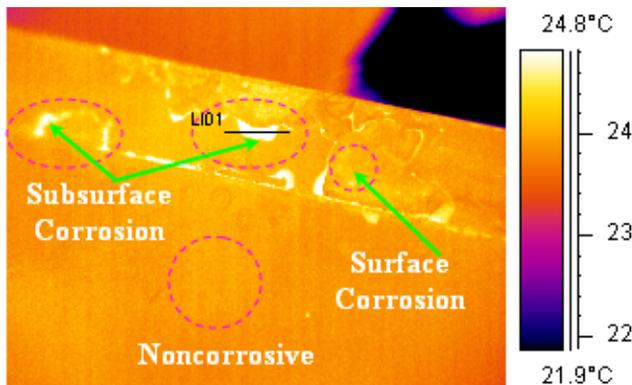
Fig.11 shows thermogram of 24th frame in the recorded sequence NEW.SEQ, after irradiation with the light impulse. In this picture it is possible to observe two surfaces marked with dotted ellipse-shaped lines where there are clearly visible light (warmer) surfaces beneath which there are areas with subsurface corrosion. The dotted line of the smaller circle shows the surface of scaled and fallen off use, so that the corrosion can clearly be seen without the use of impulse thermography method. Larger dotted circular line shows painted surface beneath which there is no subsurface corrosion.

Figure 11. Thermogram of the exit edges of tailplane surface after irradiation with the light impulse

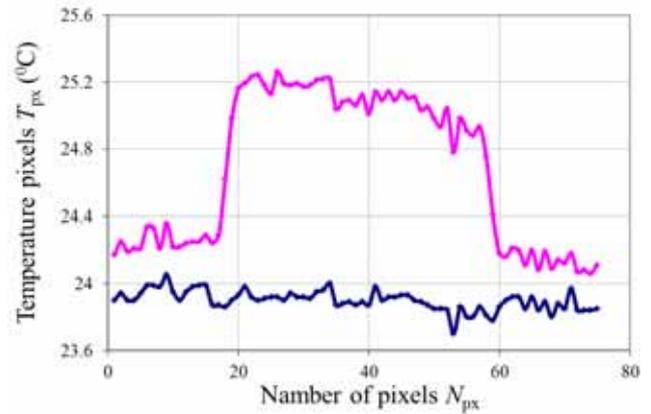
Fig.12 shows the graphs of temperature profiles along LI01 measuring line, first for the cold surface of the aircraft lining (17th frame), and then for the same surface heated (24th frame).

Figure 12. Temperature profile along measuring line LI01 of 17th and 24th frames

The upper curve represents the temperature profile along LI01 marker line of the heated surface presented on the thermogram in Fig.14. The changes in pixel temperatures of cold tail surface (the frame before irradiation with the light impulse) are within measured insecurity of 0.15°C, while on the upper curve on the central part from pixels 16 to 60 the temperature is higher for 0.8-1°C, which suggests the existence of the area with corrosion beneath the surface treated with protective coating.

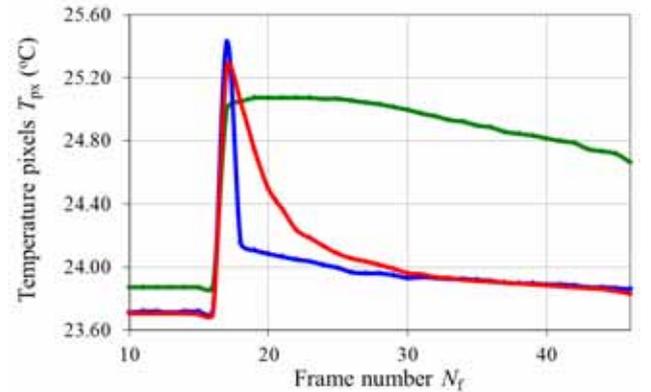
Fig.13 shows the graphs of temperature profiles in the function of number of frames within recorded sequence NEW0134.SEQ for three spots: SP01 above subsurface corrosion (green line) in the middle of LI01 line, spot SP02 in the middle of noncorrosive area and SP03, in the middle of surface corrosion.

Figure 13. Temperature profile in time SP01, SP02
