Fracture Analysis of Vehicle-Mounted Telescoping Communications Mast

In this paper a fractured connector plate for a telescoping antenna mast made of aluminum alloy EN-AW 2007 was examined. The goal of the investigation was to determine the cause of fracture which occurred during attempting to raise the antenna. Specimens taken from the mast were visually examined, and the fracture surface was examined using a scanning electron microscope. Chemical analysis, microstructural analysis, electrical conductivity measurements, tensile test and hardness test were performed in order to investigate the properties of the material. Fracture occurred fast and visual and fractographic examinations showed that there is no visible plastic deformation near the fracture surface, which are characteristics of a quasibrittle fracture. It was shown that the mechanical properties of the examined specimens do not satisfy the minimal values defined in the standard for this material. All conducted tests indicated that the material had not been heat treated and mechanically worked, so applied stress during handling/raising the antenna led to the rapid quasibrittle fracture.

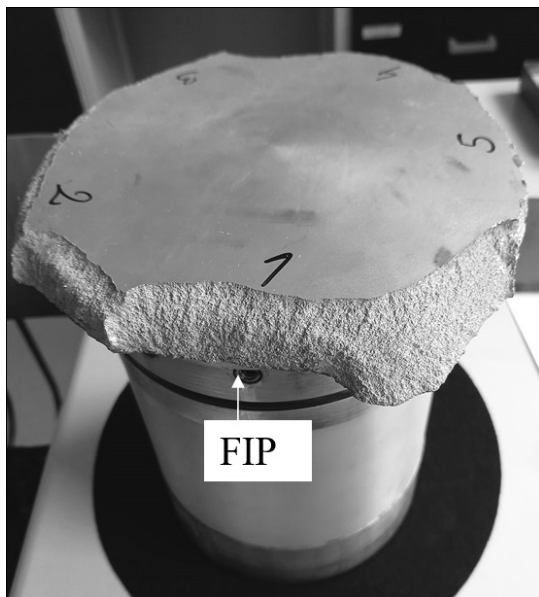
Visual examination of the fractured part showed that the fracture was initiated on the outer surface of the plate, close to the plate-to-cylinder radius, Figures 1 and 2. No visible plastic deformation near the fracture surface was observed. The fracture initiation point was identified by following the chevron pattern at the fracture surface, as shown in Figures 2 and 3. The chevron pattern pointing to the fracture initiation point is shown in Fig.3. Several secondary cracks were also visible, as shown in Fig.3. The crack propagated from the surface of the plate gradually in circumferential direction, around the cylinder, as well as, throughout the plate.

Figure 2. The fractured antenna mast, indicating the fracture initiation point - FIP.

Visual examination of the fractured mast antenna revealed that crack was initiated on the outer surface of the plate, close to the plate-to-cylinder radius (Figures 1 and 2). It is evident that the crack was initiated in a region of high localized stress, and propagated circumferentially, around the cylinder, as well as, throughout the plate.

The observed chevron pattern on the fractured surface, pointing to the fracture initiation point is characteristic of macroscopic brittle behaviour of materials [8, 9].

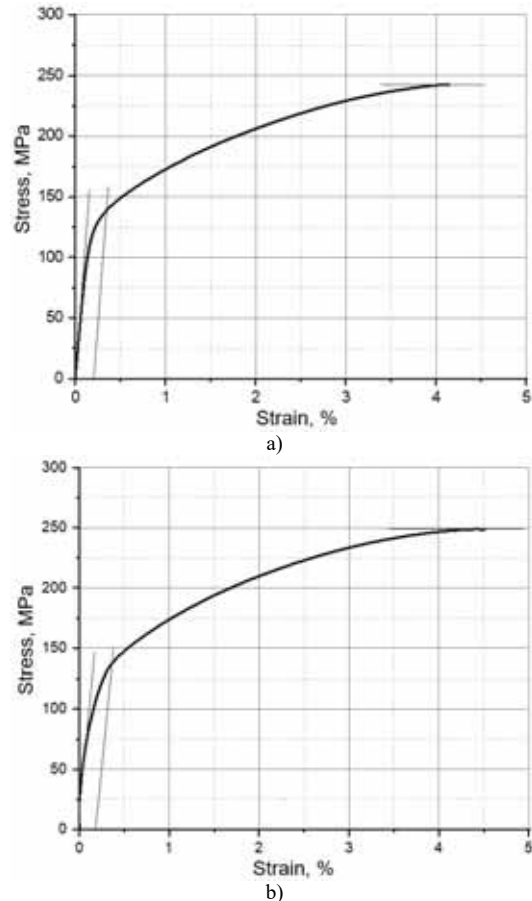
The average values of the yield strength (YS), ultimate tensile strength (UTS) and elongation (A_5) observed during tensile testing of specimens taken from the antenna mast are shown in Table 3. Characteristic stress-strain curves are shown in Fig.4. The diagrams indicate that the fracture occurs immediately after reaching the maximum force, with no posthomogenous elongation observed.

Figure 4. Characteristic stress-strain curves of tensile specimens taken from (a) the cylindrical part, (b) the connector plate of the antenna mast.

The low tensile elongation and the lack of posthomogenous elongation (Table 3 and Figure 4), as well as the macroscopically brittle appearance of the fracture, all suggest that the material was not appropriately heat treated after casting. This is also supported by the higher electrical conductivity than the typical values given in literature for EN AW-2007 in T4 condition ($18 \div 22$ MS/m i.e. $30.96 \div 37.84$ %IACS) [15, 16].

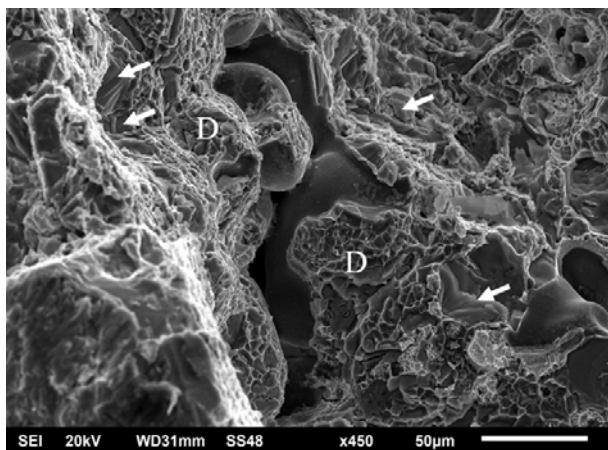
SEM analysis of the fracture surface of tested tensile samples revealed areas of transcrystalline fracture alongside with dimple areas, fractured coarse particles, as well as porosity with visible dendrites Figures 5-7.

Figure 5. Fracture surface of tensile specimens as observed by scanning electron microscopy. Areas of dimpled fracture (D) Arrows indicate the fractured particles. Interdendritic porosity is visible in the middle of the microphotograph.

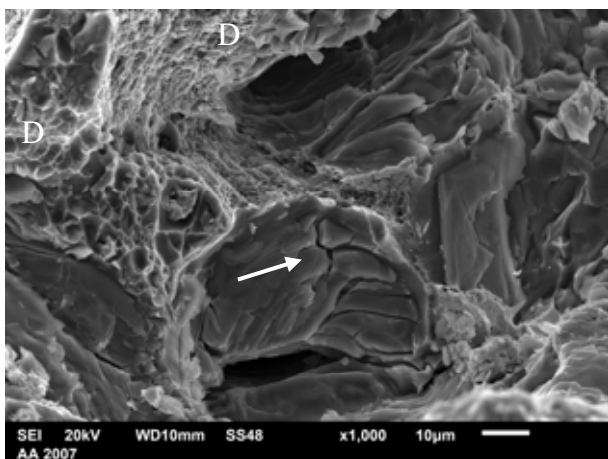
Figure 6. Fractured particles indicated by the arrow. Areas of dimpled fracture are also observed (D).

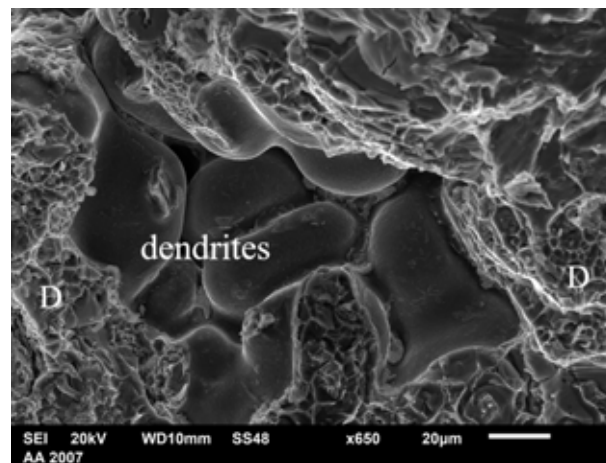
Figure 7. Fracture surface of the tensile specimens showing dimpled fracture (areas D) and exposed dendrites.

Microstructural examination has shown that mast antenna was produced of cast material. Observed dendritic grain morphology is typical for alloys in as cast condition [10]. Interdendritic porosity was observed by the light microscopy (Fig.8), and by the SEM on the fracture surface of the tensile specimens (Fig.7).

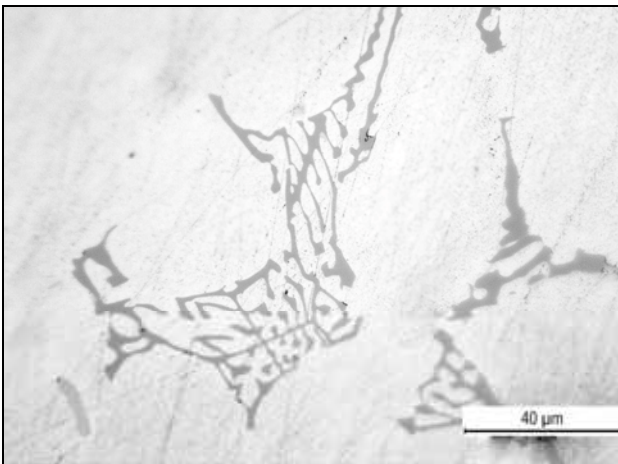
Fig.8 shows the microstructure of the specimens as polished. Large interdendritic porosity (IP), as well as large amount of shrinkage porosity (black spots) were observed in the cast microstructure. Fig.9 shows the microstructure as etched. A dendritic grain morphology was revealed.

Figure 8. Microstructure of the specimen, as polished: (a) Interdendritic porosity (IP) and shrinkage porosity (black spots), (b) shape of particles within the metal matrix. Light microscopy.

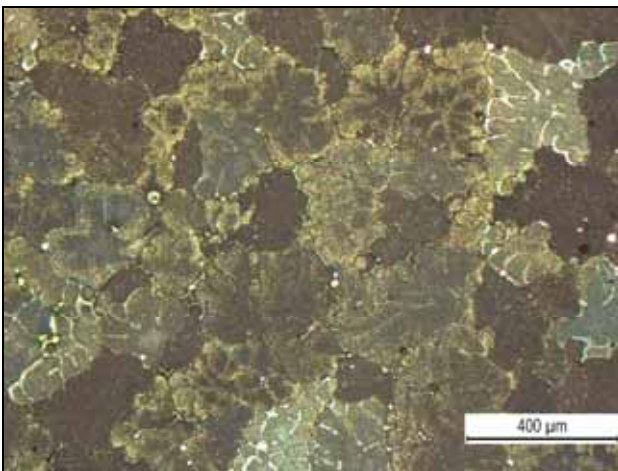
Figure 9. Microstructure of the specimen taken from the cylindrical part of the mast in perpendicular direction, etched. Dendritic grain morphology is present. Light microscopy under polarized light.
