INFLUENCE OF PRODUCTION PARAMETERS ON THE QUALITY OF SEMIFINISHED RIFLED PISTOL BARRELS

Abstract: In this paper several semi-finished rifled pistol barrels produced with different parameters were examined. The goal of the investigation was to determine the optimal production parameters for the barrels. Visual examination, microscopic analysis, SEM/EDS analysis and hardness tests were performed. The material of the barrels is 42CrMo4 steel. The caliber of the barrel is 9mm, and spiral grooves at the inside surface of the barrels were observed. Micro-cracks at the groove roots and geometrical deviances of the grooves were revealed in the specimens that were heat-treated by quenching and tempering. This indicates that improper rifling and/or heat treatment parameters were used during the production process for these specimens. On the specimen heat-treated by austenitization + continuous cooling no micro-cracks and geometrical deviances were observed, indicating that these heat treatment parameters are optimal for the subsequent process of rifling.

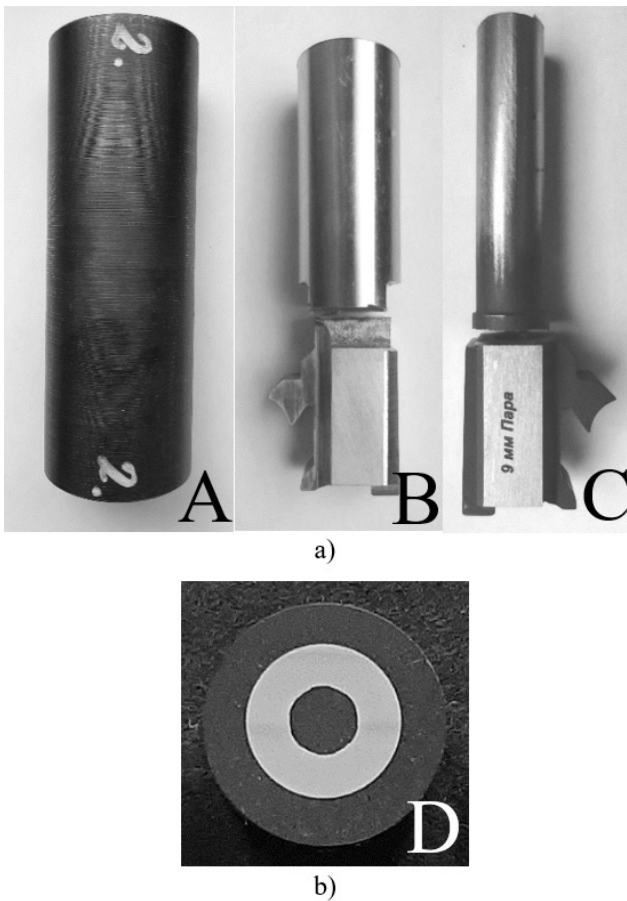
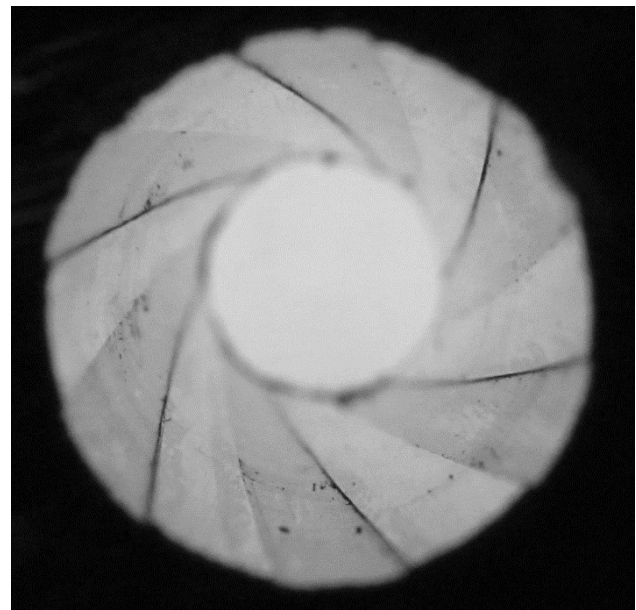
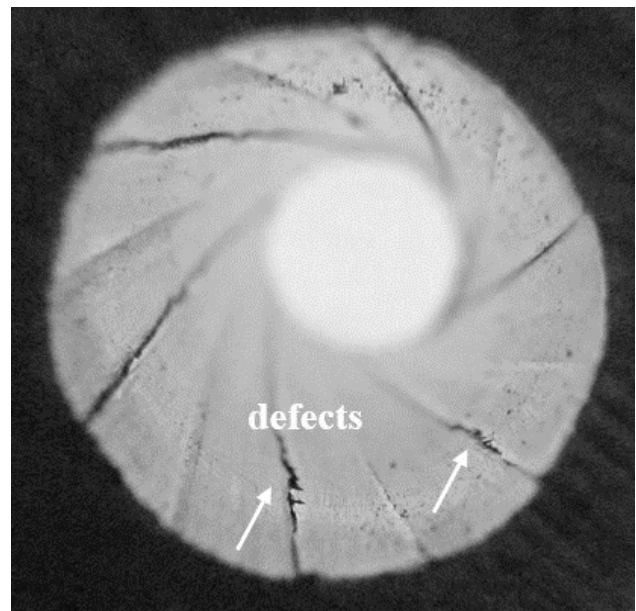
Figure 2. Pistol barrel specimens. (a) Initially examined pistol barrels A, B and C, in three different stages of barrel production. (b) Sample D cut in perpendicular direction from the subsequently produced pistol barrel.

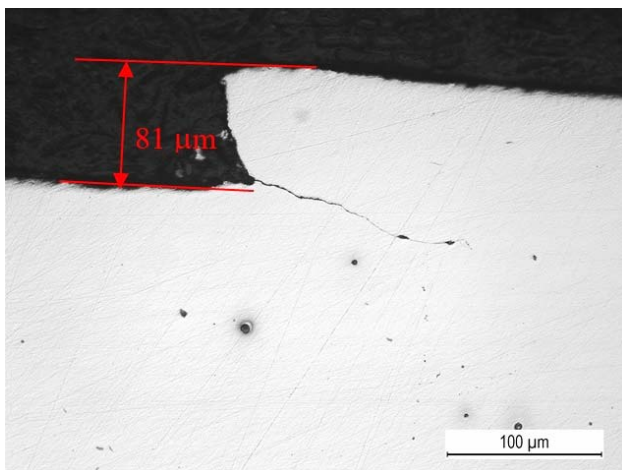
Micro-structural analysis of the specimens A, B and C as polished revealed cracks propagating from the sharp groove corner to the inner side of the barrels, Figure 4. Cracks length around 100 µm were observed on every groove on the specimens. The presence of cracks probably caused the macroscopic defects of the spiral grooves on specimen C. The angle of the groove corners is acute. It was also observed that the groove depth does not meet the requirements of the technical drawing of the barrels.

Figure 4. Microstructure of specimen A, as polished. Cracking at the groove corner.

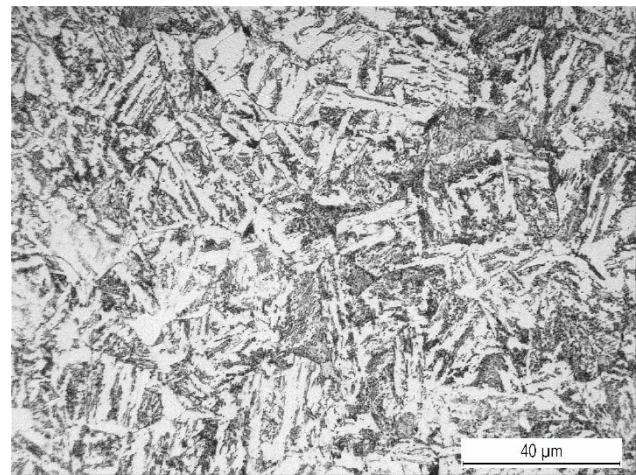
Figure 5. Microstructure of specimen B, etched.

Microstructure of the specimens A, B and C is tempered martensite, with a few visible ferrite grains. Figure 5 shows the microstructure of specimen C after etching.

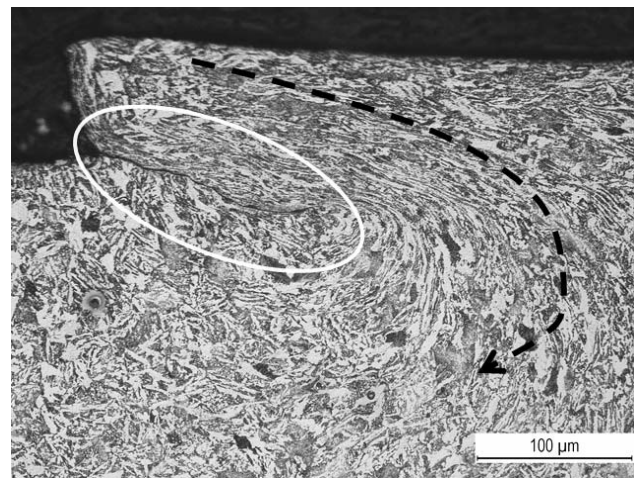
Figure 6. Microstructure of specimen A in the groove zone. The arrow indicates the material flow direction. Encircled is the crack at the groove corner.

Significant material flow in the groove zone was observed on specimens A, B and C, Figure 6. The cracks on the grooves appear to follow the material flow direction.

The microstructure of etched specimens A, B and C is in accordance with microstructure of steel 42CrMo4 in quenched and tempered condition [5,6]. There was significant material flow around the corners of the grooves, as a consequence of a rifling process involving cold deformation. The surface layer observed on specimen C is a consequence of a surface hardening process [7]. SEM/EDS analysis of specimen C confirmed the presence of a nitride layer on the barrel inside. This layer is also present around the groove cracks, indicating that the cracking occurred before the process of nitrating. The accicularity of the tempered martensite microstructure, as well as significant material deformation around the corners of the grooves, are factors that contributed to making the material more susceptible to cracking.

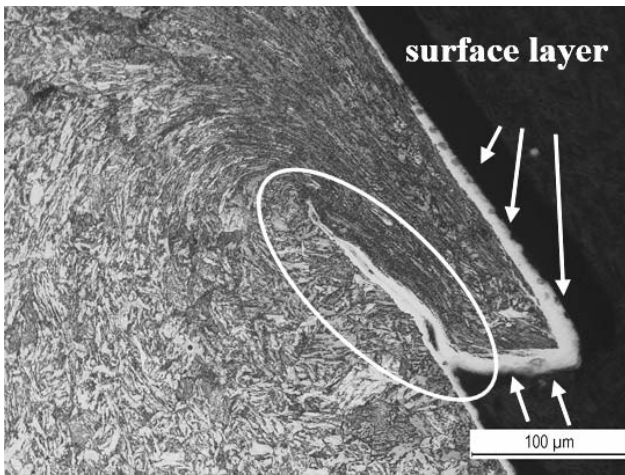
Presence of a surface layer was observed on specimen C, Figure 7. This layer is also present around the groove cracks.

Figure 7. Microstructure of specimen C, etched. Encircled is the crack at the groove corner.

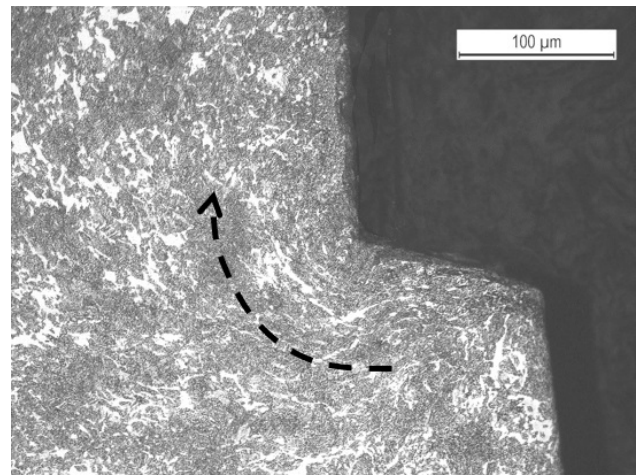
The microstructure of etched specimen D is shown in Figures 9 and 10. The microstructures consist predominately of fine pearlite and ferrite grains. The material flow around the groove corners is less pronounced than in specimens A, B and C.

Figure 10. Microstructure of specimen D in the groove zone. The arrow indicates the material flow direction.

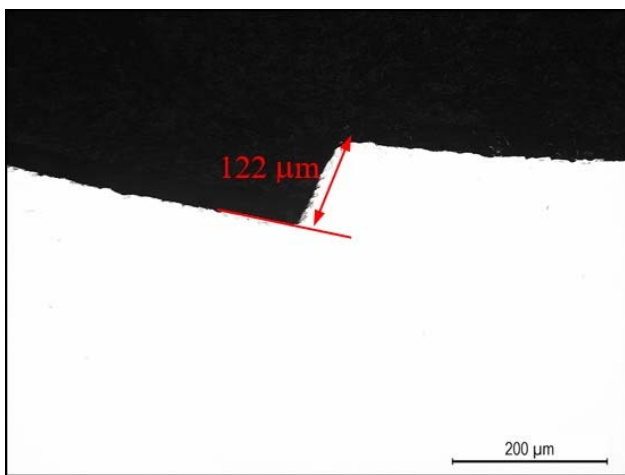
Figure 8 shows the microstructure of specimen D, as polished. No cracks were observed at the grooves. The grooves are of sufficient depth, as required by the technical drawing of the barrels (Figure 1).

Figure 8. Microstructure of specimen D, as polished.

In order remedy the observed defects, a further barrel (specimen D) was produced with different heat treatment parameters (austenitization + continuous cooling) and examined. No fractures at the grooves were observed on specimen D, and the microstructural analysis showed less pronounced material flow on the barrel inside and a better geometry of the grooves than on quenched and tempered specimens. It can be concluded that the production parameters of pistol barrel D are appropriate for the process of rifling.

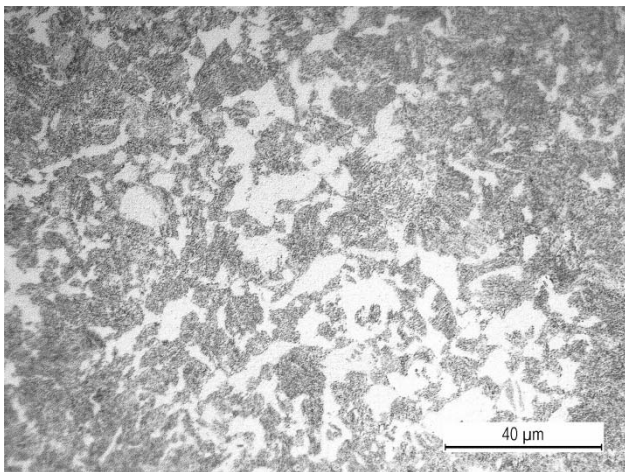
Figure 9. Microstructure of specimen D, etched.

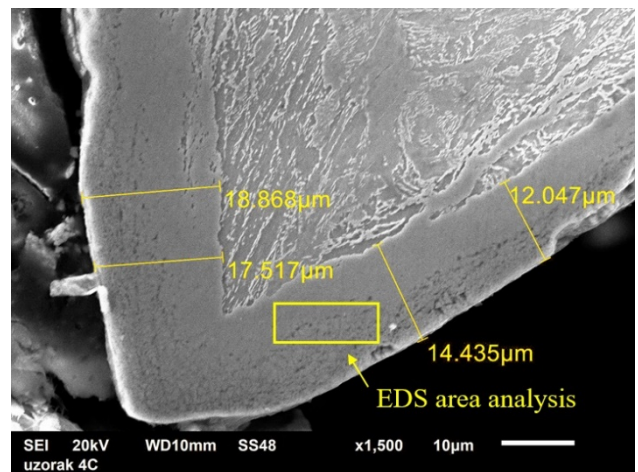
SEM and EDS analysis of specimen C identified the presence of a nitrogen-rich surface layer on the inner side of the pistol barrel, Figures 11 and 12. The nitride layer thickness is between 12 and 19 μm. The EDS analysis results are shown in Table 3.

Figure 11. Microstructure of the groove tip zone on specimen C, as observed by scanning electron microscopy.

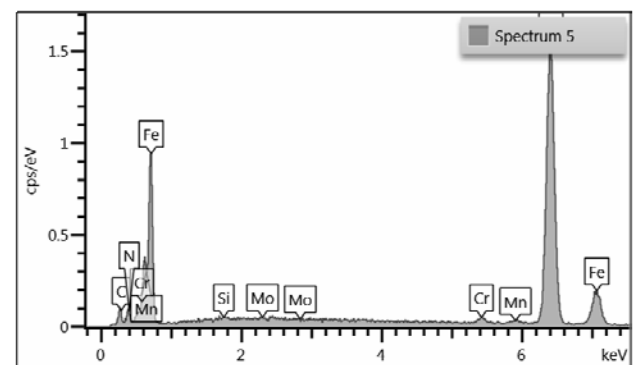
Figure 12. EDS analysis of the surface layer shown in Figure 11.
