## FRACTURE ANALYSIS OF VEHICLE-MOUNTED TELESCOPING COMMUNICATIONS MAST

**Abstract:** In this paper a fractured connector plate for a telescoping antenna mast made of aluminum alloy EN-AW 2007 was examined. The goal of the investigation was to determine the cause of fracture which occurred during attempting to raise the antenna. Specimens taken from the mast were visually examined, and the fracture surface was examined using a scanning electron microscope. Chemical analysis, microstructural analysis, electrical conductivity measurements, tensile test and hardness test were performed in order to investigate the properties of the material. Fracture occurred fast and visual and fractographic examinations showed that there is no visible plastic deformation near the fracture surface, which are characteristics of a quasibrittle fracture. It was shown that the mechanical properties of the examined specimens do not satisfy the minimal values defined in the standard for this material. All conducted tests indicated that the material had not been heat treated and mechanically worked, so applied stress during handling/raising the antenna led to the rapid quasibrittle fracture.

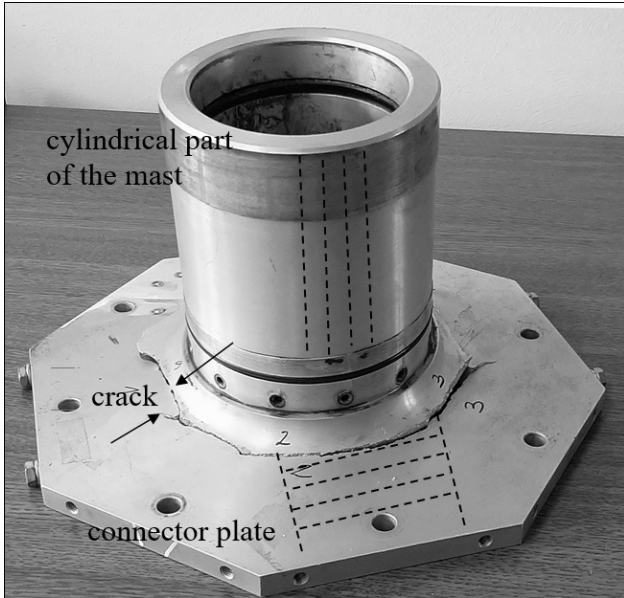
A photograph of the base of the mast is shown in Figure 1. The cylinder and connector plate were machined from one round bar with a diameter of at least 370 mm.

**Figure 1.** The fractured antenna mast. Dashed lines represent the location of samples for tensile testing.

Visual examination of the fractured part showed that the fracture was initiated on the outer surface of the plate, close to the plate-to-cylinder radius, Figures 1 and 2. No visible plastic deformation near the fracture surface was observed. The fracture initiation point was identified by following the chevron pattern at the fracture surface, as shown in Figures 2 and 3. The chevron pattern pointing to the fracture initiation point is shown in Figure 3. Several secondary cracks were also visible, as shown in Figure 3. The crack propagated from the surface of the plate gradually in circumferential direction, around the

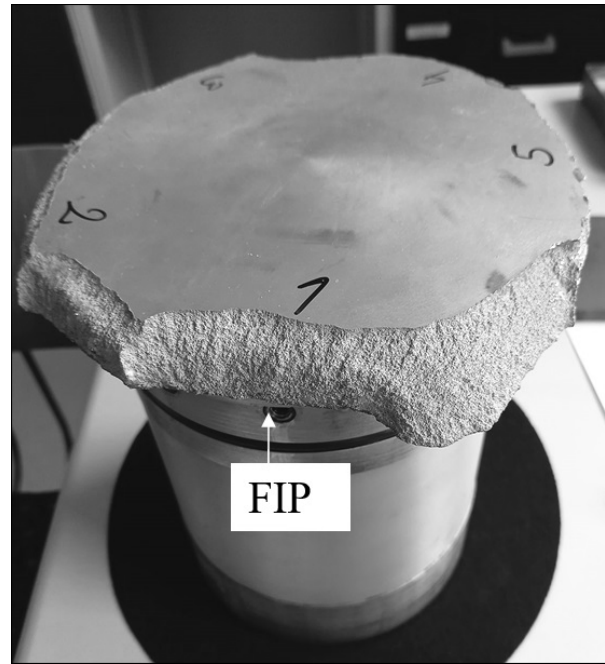
**Figure 2.** The fractured antenna mast, indicating the fracture initiation point - FIP.

Visual examination of the fractured mast antenna revealed that crack was initiated on the outer surface of the plate, close to the plate-to-cylinder radius (Figure 1 and 2). It is evident that the crack was initiated in a region of high localized stress, and propagated circumferentially, around the cylinder, as well as, throughout the plate.

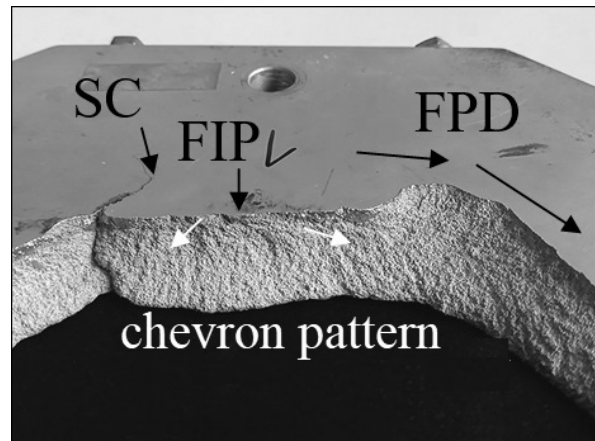
**Figure 3.** Plate-side fracture surface. FIP - fracture initiation point, FPD - fracture propagation direction, SC - secondary crack.

The observed chevron pattern on the fractured surface, pointing to the fracture initiation point is characteristic of macroscopic brittle behaviour of materials [8, 9].

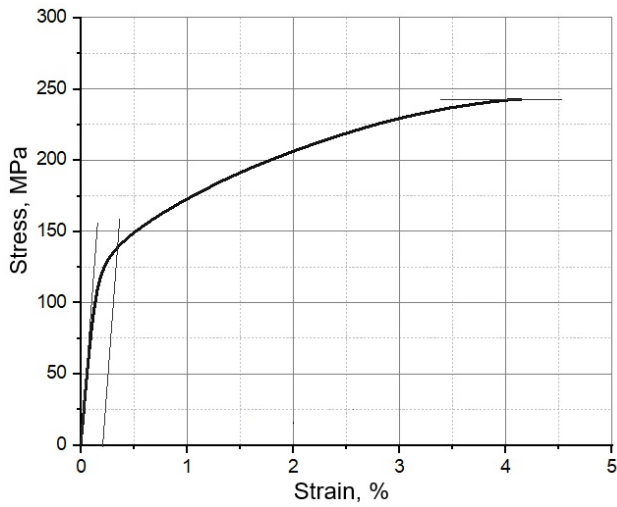
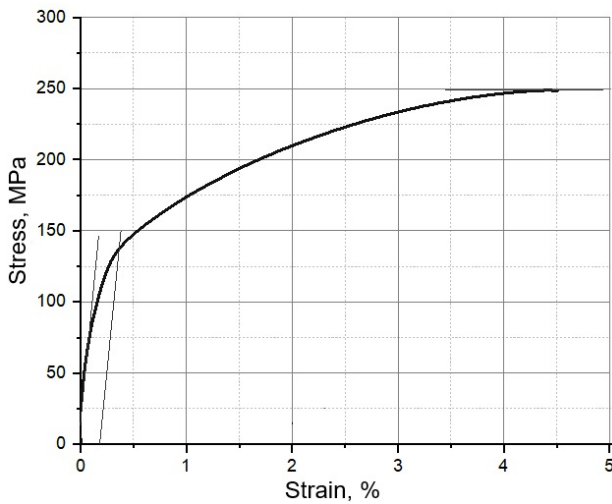
mast are shown in Table 3. Characteristic stress-strain curves are shown in Figure 4. The diagrams indicate that the fracture occurs immediately after reaching the maximum force, with no posthomogenous elongation observed.

**Figure 4:** Characteristic stress-strain curves of tensile specimens taken from (a) the cylindrical part, (b) the connector plate of the antenna mast.

The low tensile elongation and the lack of posthomogenous elongation (Table 3 and Figure 4), as well as the macroscopically brittle appearance of the fracture, all suggest that the material was not appropriately heat treated after casting. This is also supported by the higher electrical conductivity than the typical values given in literature for EN AW-2007 in T4 condition ( $18 \div 22$  MS/m i.e.  $30.96 \div 37.84$  %IACS) [15, 16].

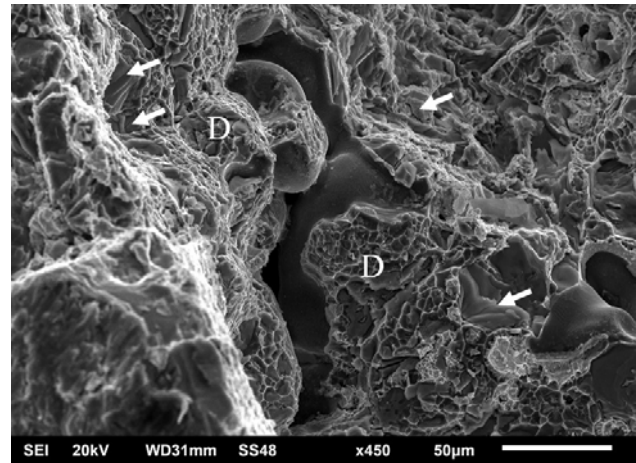
SEM analysis of the fracture surface of tested tensile samples revealed areas of transcrystalline fracture alongside with dimple areas, fractured coarse particles, as well as porosity with visible dendrites Figures 5, 6 and 7.

**Figure 5.** Fracture surface of tensile specimens as observed by scanning electron microscopy. Areas of dimpled fracture (D) Arrows indicate the fractured particles. Interdentritic porosity is visible in the middle of the microphotograph.

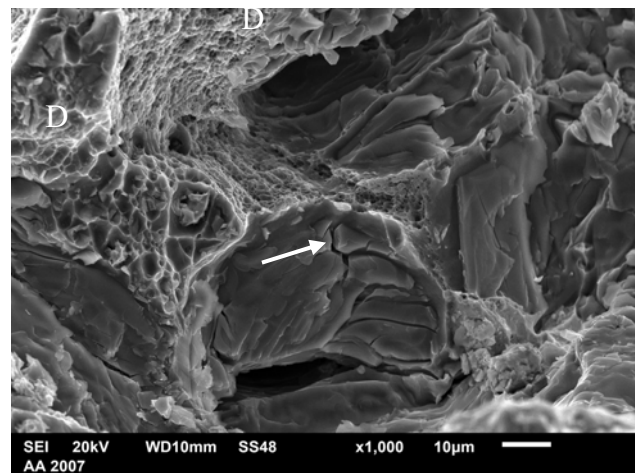
**Figure 6.** Fractured particles indicated by the arrow. Areas of dimpled fracture are also observed (D).

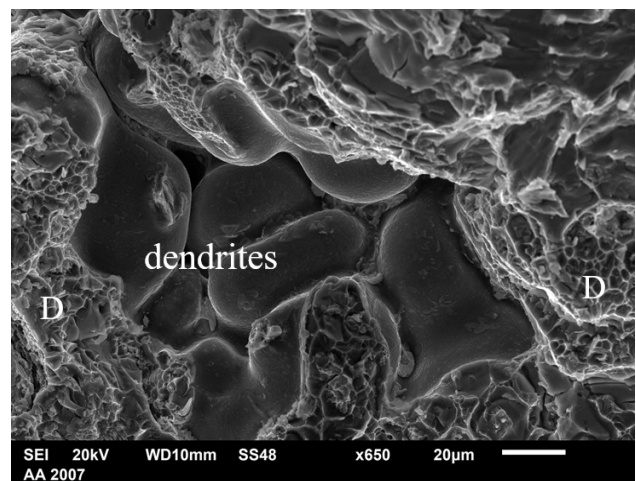
**Figure 7.** Fracture surface of the tensile specimens showing dimpled fracture (areas D) and exposed dendrites.

Microstructural examination has shown that mast antenna was produced of cast material. Observed dendritic grain morphology is typical for alloys in as cast condition [10]. Interdendritic porosity was observed by the light microscopy (Figure 8), and by the SEM on the fracture surface of the tensile specimens (Figure 7).

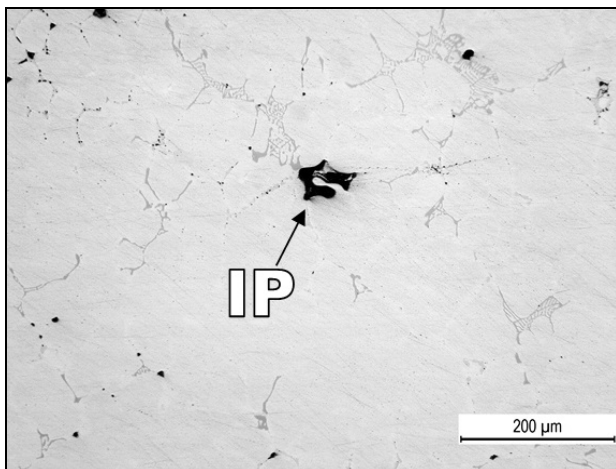
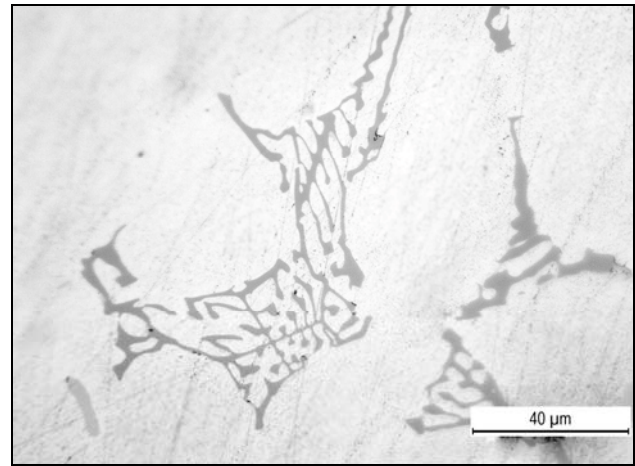
Figure 8 shows the microstructure of the specimens as polished. Large interdendritic porosity (IP), as well as large amount of shrinkage porosity (black spots) were observed in the cast microstructure. Figure 9 shows the microstructure as etched. A dendritic grain morphology was revealed.

**Figure 8.** Microstructure of the specimen, as polished: (a) Interdendritic porosity (IP) and shrinkage porosity (black spots), (b) shape of particles within the metal matrix. Light microscopy.

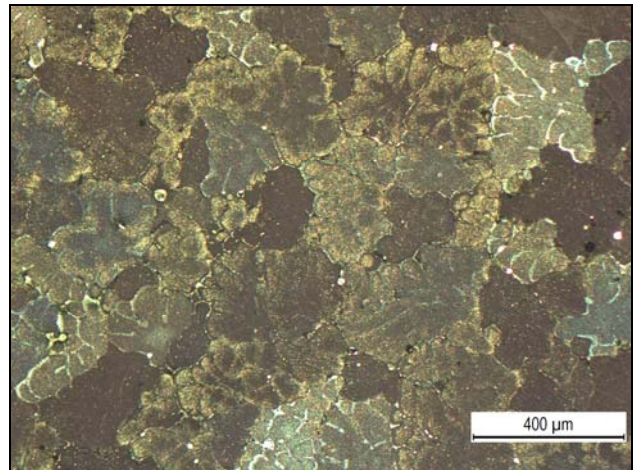
**Figure 9.** Microstructure of the specimen taken from the cylindrical part of the mast in perpendicular direction, etched. Dendritic grain morphology is present. Light microscopy under polarized light.
