Failure Investigation: Analysis Procedure and Some Notable Aircraft and Aeroengine Service Failures

Ivan Lazarević¹⁾
 Zoran Petrović¹⁾

Key words: aircraft, helicopter, propeller, rotor of the helicopter, corrosion, failure, analysis of processes, fractography

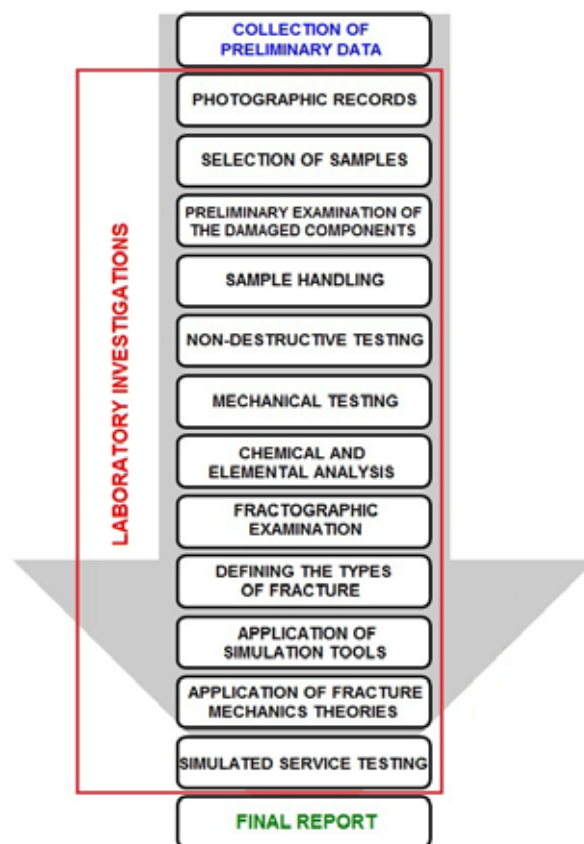
Figure 1. Failure Investigation Process Flow

The nature of the failure being investigated determines what steps and processes must be employed. The following is a brief description of the typical stages of the Failure Investigation. These are guidelines to be considered by the investigator; however, not every stage may be utilized [2].

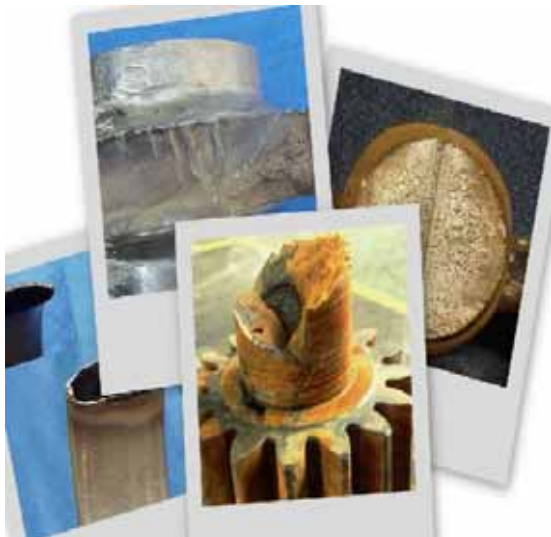
Figure 4. Fractographic records [4]

Fracture surface is a source of information regarding the cause of the fracture. It contains the evidence about the material disadvantages, the impact of the environment, as well as the use of force.

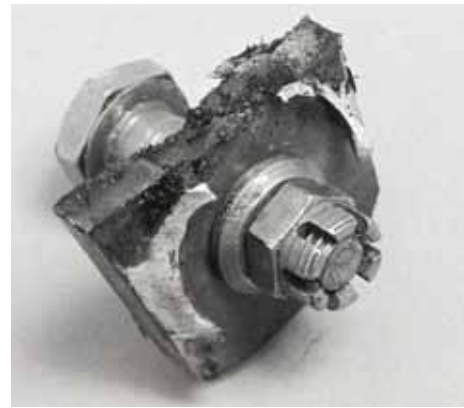
Figure 5. Details of the lug fracture, which was close to welds joining the lug into the airframe. (In October 1990 a Aérospatiale Alouette III helicopter crashed in the Veluwe). [6]

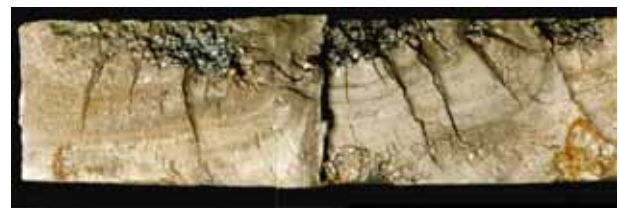
Figure 6. Details of the tail lug fracture, showing intergranular cracking followed by the fatigue. The failure occurred by the fatigue initiating from intergranular cracks on the upper side. The intergranular cracks were heat-tinted. (In October 1990 a Aérospatiale Alouette III helicopter crashed in the Veluwe). [6]

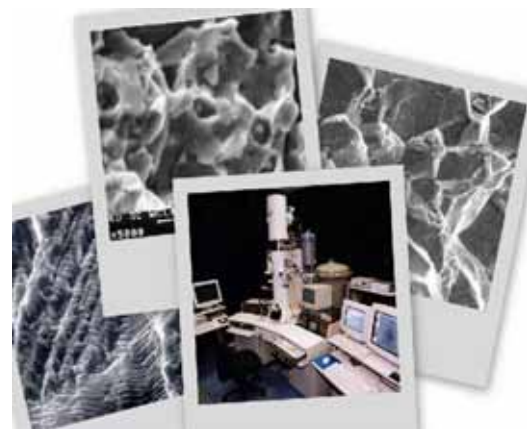
Figure 7. Microscopic records

Metallurgical imperfections or impurities and microstructural segregation in metals, such as voids (holes) in polymer composites can be detected and analyzed by a microscopic examination [2].

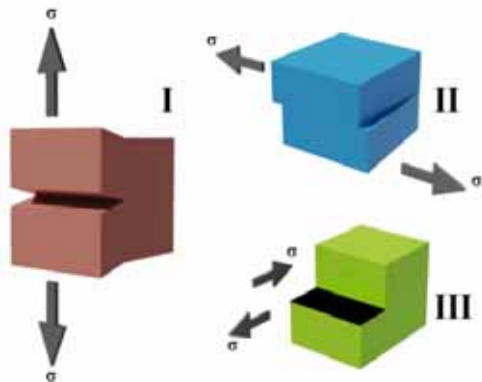
Figure 8. Basic shapes of crack development and shaping of the fracture surface [5]

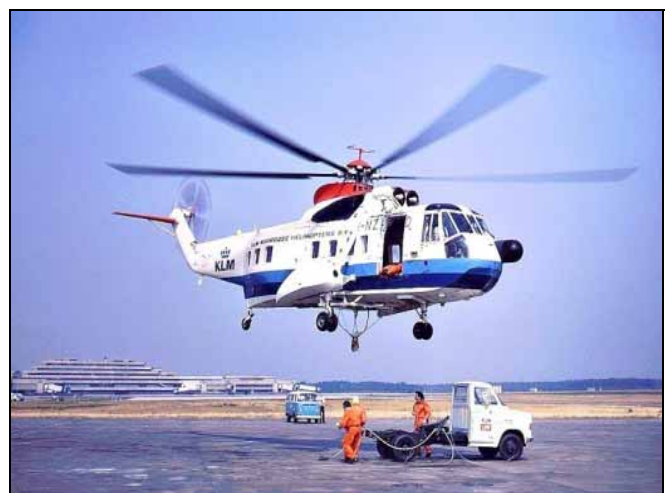
Figure 9. Sikorsky S-61N PH-NZD [6]

In May 1974 a Sikorsky S-61N helicopter crashed into the North Sea with the loss of six lives. Fig.9 shows the aircraft type and Fig.10 shows the crashed helicopter during the recovery. All the main rotor blades were broken, but the blade 3 was exceptional in showing little deformation at the fracture location (indicated in Fig.10) [6,7].

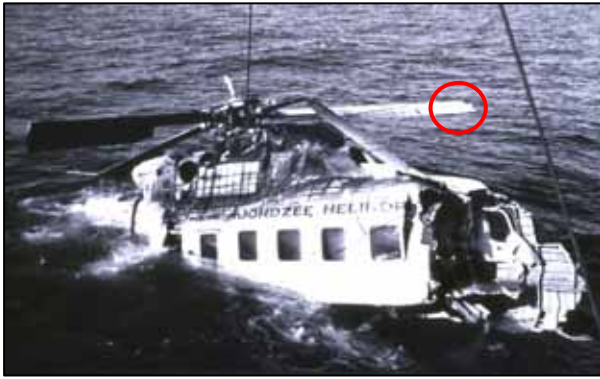
Figure 10. Recovery of the Sikorsky S-61N PH-NZD from the North Sea [6]

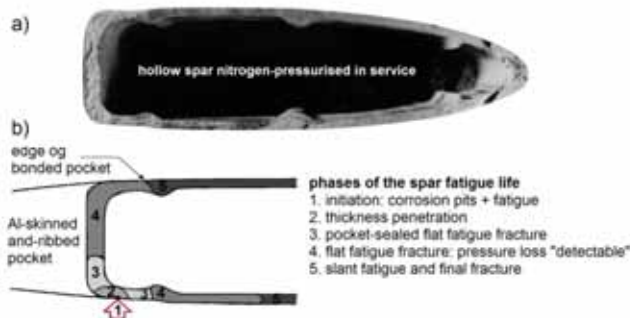
Fig.11a shows the recovered fracture surface of the blade 3, consisting of a hollow spar made from aluminium alloy AA6061-T6. The spar had been adhesively bonded to aluminium face in form of the ribbed aluminum pocket, as shown in Fig.11b. The first phase in the failure sequence determined from the fractographic analysis was a high-cycle fatigue initiating from the corrosion pits on the spar lower surface under the bonded area (indicated by the red arrow in Fig.11b) [6,7].

Figure 11. Recovered blade spar fracture surface and phases of the fatigue life [6]

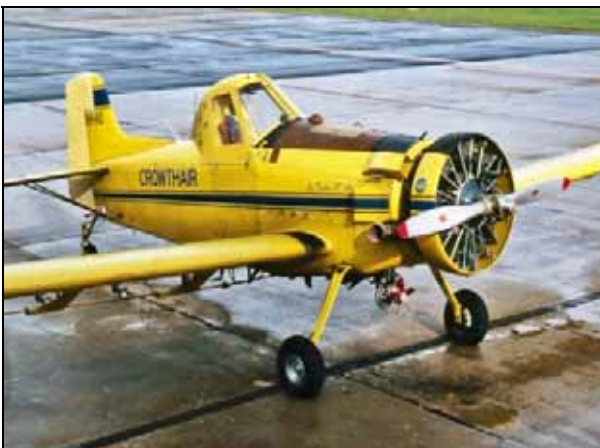
Figure 12. Air Tractor AT-301 (with a two-bladed propeller) [6]

In June 1987 an Air Tractor AT-301 fitted with a two-bladed propeller experienced loss of a propeller tip in flight. The pilot managed to switch the engine off and landed safely.

Figure 12 shows the Air Tractor AT-301 aircraft at the time of the accident with a two-bladed propeller, while Figure 13 shows the same plane a year later, but this time with a three-bladed propeller [6,8].

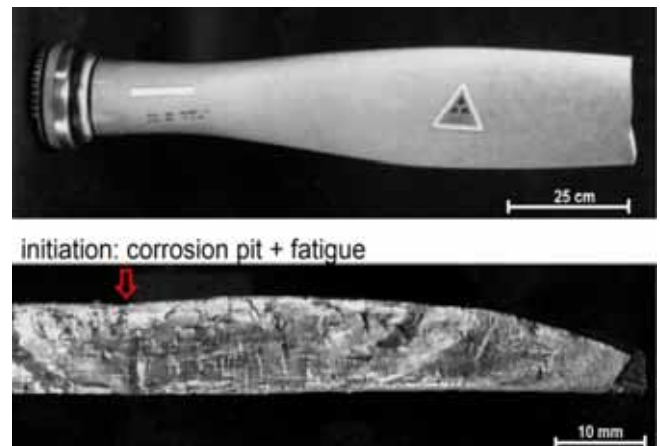
Fig.14 shows the broken propeller blade and a detail of its fracture surface. The propeller was manufactured by Pacific Propellers Inc., under the license to Hamilton Standard, and consisted of an aluminium alloy AA2025-T6 forging that had been chromic acid anodised. Despite the anodized surface, the propeller showed pitting and exfoliation corrosion. The corrosion was most probably due to attack and penetration of the anodised layer by deposits, which included sea salt. The broken blade failed by high-cycle fatigue initiating from a 0.1 mm deep \times 0.3 mm long corrosion pit on the convex surface [6,8].

Figure 14. Broken propeller blade and a detail of the fracture surface [6]

Propeller cleaning: The operator neglected to follow the manufacturer's recommendation to wash and oil the propeller blades after the last flight of the day.

Operating environment: The aircraft was used for crop spraying near the Dutch coast. This resulted in aggressive deposits on the propeller.

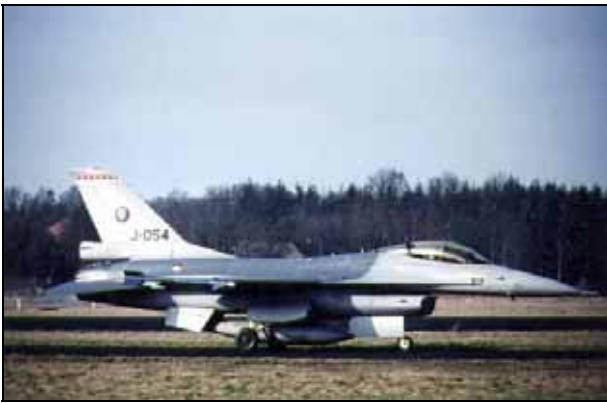
Figure 15. General Dynamics F-16 J-054

In February 1992 a General Dynamics F-16 crashed between housing blocks in the city of Hengelo, without a loss of life. The crash was caused by an engine failure.

Figure 15 shows the General Dynamics F-16, while Figure 16 shows the crash site, including the remains of the Pratt & Whitney F100-PW-220 engine. Fig.17 indicates the location of the engine failure, which was due to a fracture of a pin attached to a Rear Compressor Variable Vane (RCVV) lever arm [6,9].

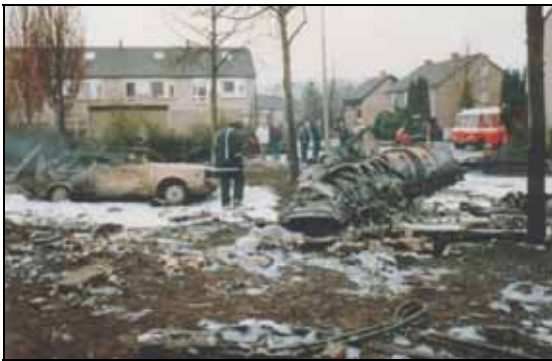
Figure 16. Crash site of F-16 J-054 and an indication of the engine [6]

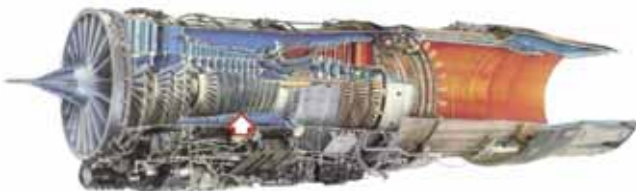
Figure 17. F100-PW-220 engine failure location: RCVV lever arm assembly [6]

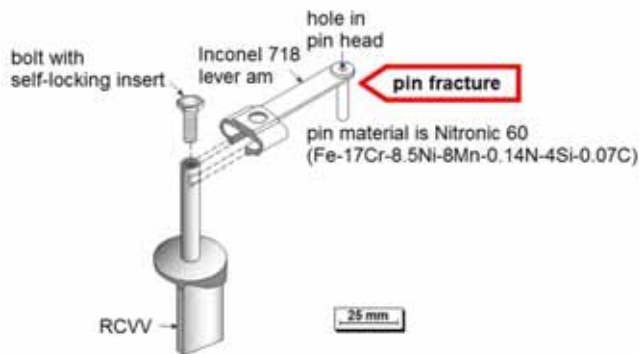
Figure 18. Schematic of RCVV and lever arm assembly, indicating the fracture of the pin attached to the lever arm [6]

The lever arm material was Inconel 718, a nickel-base superalloy. The pin material was Nitronic 60, a stainless steel. Detailed investigation showed that the pin had undergone stress corrosion cracking (SCC).

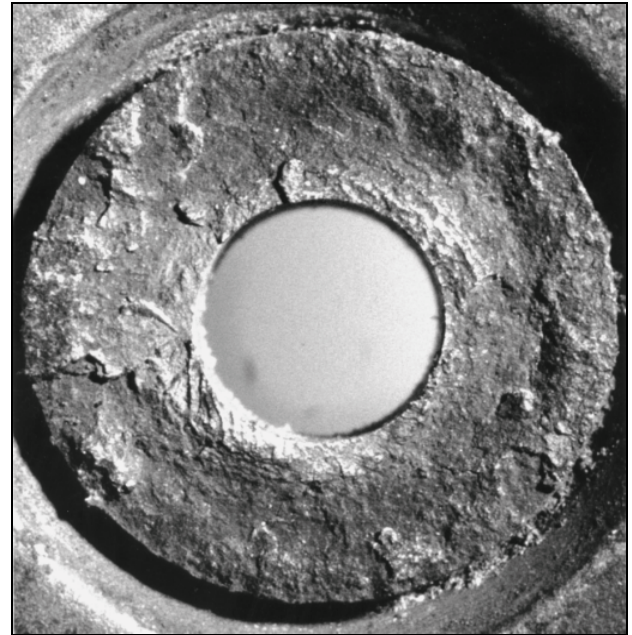
Figure 19. As-received fracture surface of the lever arm pin [6]

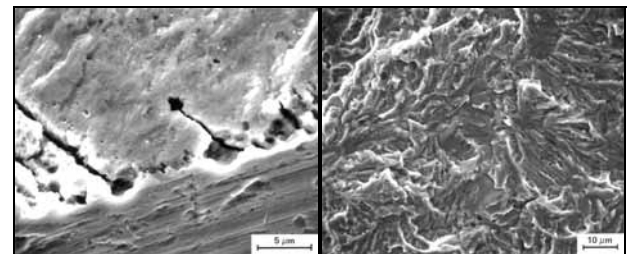
Pin material: The SCC susceptibility of Nitronic 60 was unknown, until identified by the NLR.

Residual stresses: Cold-upsetting the pin head to attach it to the RCVV lever arm resulted in high residual stresses. The combination of these stresses and a concentrated salt solution in the crevice between the lever arm and pin resulted in SCC. Figures 19 and 20 show the pin fracture surface and an evidence of the corrosion and SCC. The actual (physical) cause of the engine failure involved a sequence of events, see Figure 21 [6,9].

Figure 20. Corrosion and stress corrosion cracking of the lever arm pin (1. corrosion pits and slots running from hole in pin head, 2. transgranular SCC) [6]
