Prototype SOVA Development: Aircraft Lyfe Cycle Extension

With the aim of a new aircraft development, single engine four-seater aircraft with fixed landing gear, analysis of the existing structure has been conducted. Analysed subject was earlier produced UTVA 75 structure, which has been used as the basis of the new aircraft prototype. Elements of the structure were tested with different Non-Destructive Testing (NDT) methods. This paper describes condition of existing structure and its test results, as well as necessary repairs and replacement of the damaged parts, in order to extend life cycle of the structure.

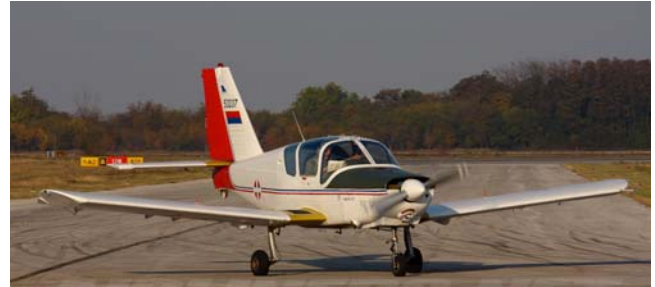
Figure 1. Utva 75 aircraft

All metal *Utva 75* aircraft, certified according to FAR 23, is side-by-side seating configuration with an advantage that pilot and instructor can see each other's actions. With the conversion in four-seater aircraft, future generation pilots will be able, since being in the back seats during the flight, to learn from the instructor and pilot by watching. Special advantage of this aircraft version (four-seater *Sova*), which can be used for the initial training of several trainees, is considerably reducing the cost of the training. That is the reason why nowadays popularity of the four-seater trainer is increased all around the world.

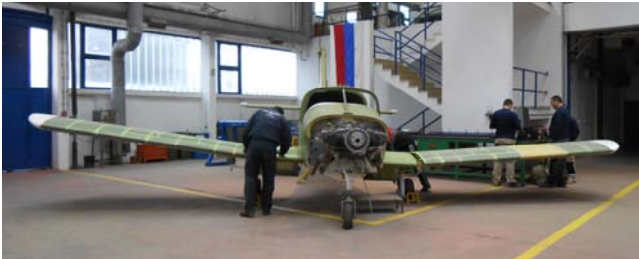
With some past experience of *Utva 75* conversion in four-seater aircraft, the feasibility study started and conclusion was made. *Utva 75* structure meets the performance goals of a new aircraft with some changes in the cockpit area, upgraded avionics and with redesign of propulsion and controls, prototype could be finalized shortly. The decision that the prototype is going to be conversion of the *Utva 75* off-the-shelf structure was made, and it is presented in Fig. 2.

Figure 2. Future prototype structure

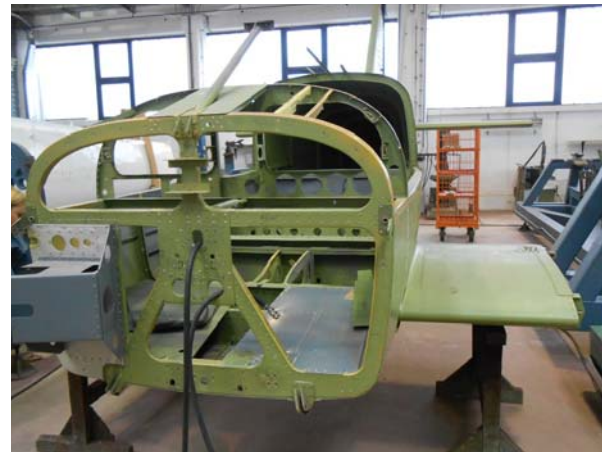
The aircraft chosen to be a prototype was made of main assemblies of already produced *Utva 75*, whole metal structure. Wing, horizontal and vertical stabilizer were in storage and were never used, with an exception of the fuselage, the elevator and the rudder that were in use for short period of time. The testing was conducted in the facilities of the *UTVA AI* with a help of a factory personnel. They performed first measures by checking the geometry of the aircraft. Structure testing was next step of the extending life-cycle process. In Fig.3 is shown fuselage of *Utva 75* aircraft.

Figure 3. Fuselage in the *UTVA AI* facilities

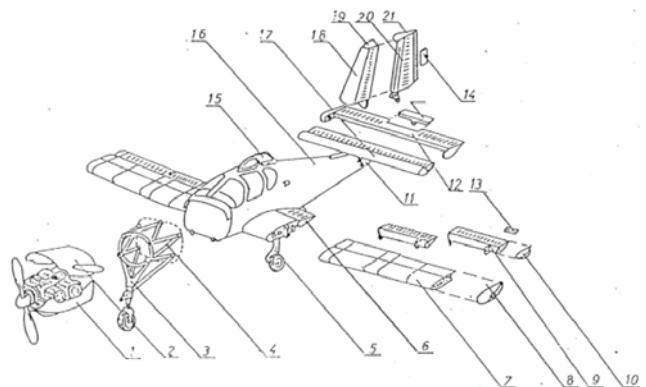
Figure 4. Main examined structural elements and assemblies

In Fig.4 main structural assemblies of the examined structure are presented (wing, fuselage, vertical and horizontal stabilizer, ailerons, elevator, and rudder). Some of the major defects of the examined structure, classified by main assemblies, are presented in the further text.

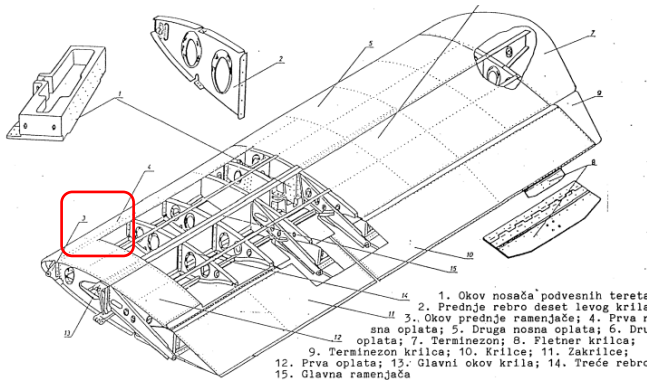
- **Wing** was never in operational use; nevertheless the process of examination was detailed. NDT methods that have been applied here are: VT and ES for outer and inner surfaces and elements (skin, spars, ribs...), then ECT for bolts, joints and UT for fittings, rivets and axels inspection.
- Location of the above mentioned defects is presented in the Fig.5.

Figure 5. Left and right wing – damaged zone

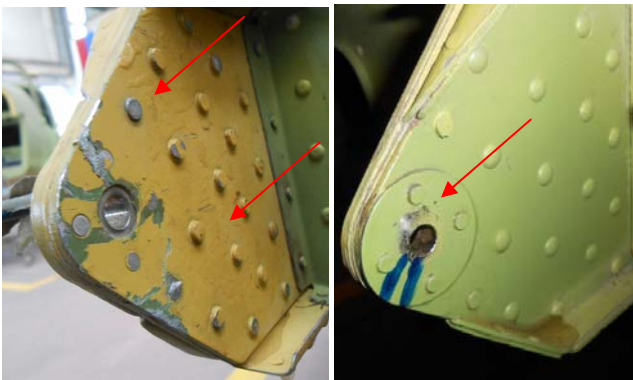
The main defect was found in the bushing of the front spar left wing fitting (Fig.6 - right). Irregularities were found with UT and described as a lack of homogeneity. Also, some mechanical damages were found on the front spar right wing fitting (Fig.6 - left).

Figure 6. Left – left wing fitting mechanical defects Right – right wing bushing defect of homogeneity

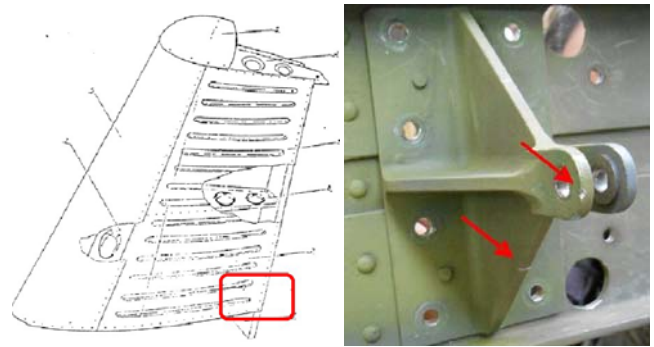
- **Vertical stabilizer** was in storage and its inner structure was tested with ES and was healthy. Brackets were tested with UT and had no inner flaws, but some mechanical damages on the surface, at the lower bracket, were found. Location of the bracket and its irregularities is shown in Fig.7.

Figure 7. Left - vertical stabilizer - damaged zone Right - lower bracket, mechanical defects

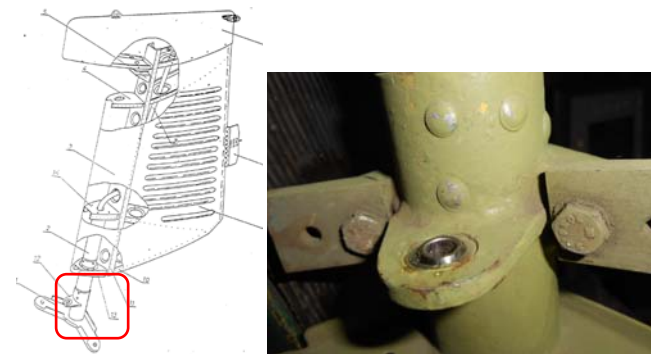
- **Rudder** was in operational use and had corrosion on the torsion tube. NDT methods confirmed that the damage is only on the surface, and with adequate treatment and protection it can easily be removed. Location of the torsion tube and its damage is presented in Fig.8.

Figure 8. Left – rudder - damaged zone Right – torsion tube corrosion

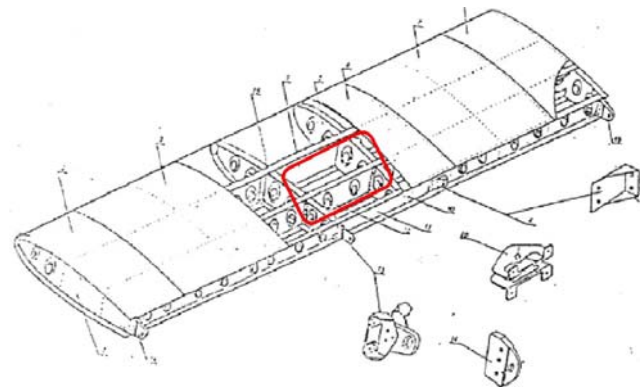
- **Horizontal stabilizer** had traces of surface corrosion on the fittings that connect stabilizer with frame no.11 in the fuselage. Location of the fitting is presented in the Fig.9.

Figure 9. Horizontal stabilizer - damaged zone

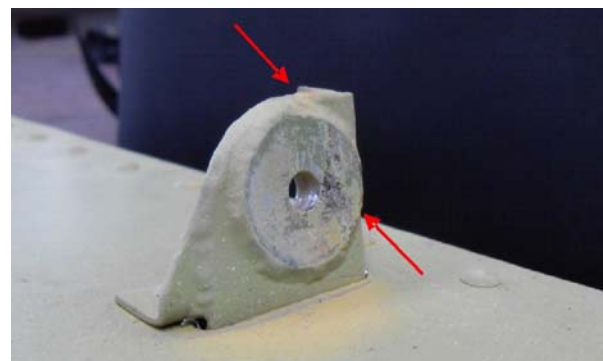
NDT methods have confirmed that inner material of the fitting is without irregularities, and corrosion exists on a surface only. Damages of the fitting are shown in the Fig.10.

Figure 10. Corrosion of the horizontal stabilizer fitting

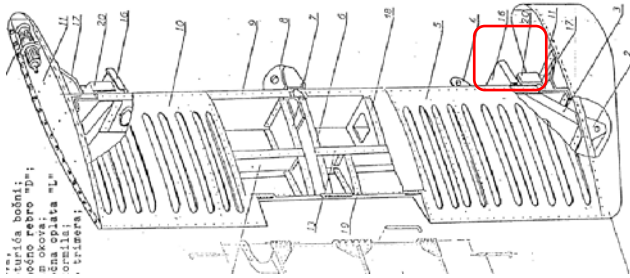
- **Elevator** was in the operational use and had some mechanical deformations of the skin which was noticed by VT. Deformation of the upper skin near the outer rib appeared as a consequence of the wrong manipulation. Location of the deformed skin is presented in a Fig.11 and mechanical damages in Fig.12.

Figure 11. Horizontal stabilizer - damaged zone

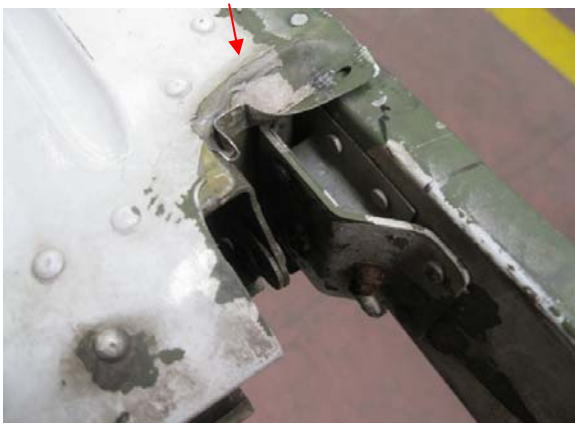
Figure 12. Deformed skin of the horizontal stabilizer

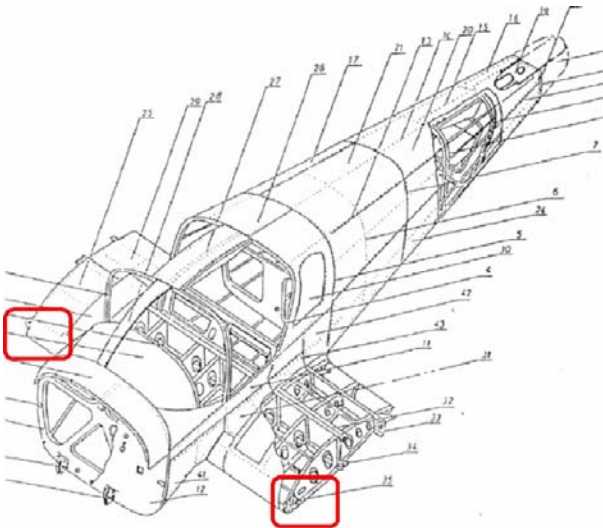
Figure 13. Fuselage - damaged zone

- **Fuselage** was in operational use and demanded more dedication and work, in order to examine the whole structure from the first to the last frame. The important information was that the greatest number of modifications were performed on the fuselage, and the most of the structure from the cockpit was changed during the process of examination. All NDT methods were used in order to locate defects of the material. Main tests were performed on the fittings that connect fuselage with wing and horizontal and vertical stabilizer and engine mount with the

fuselage. They were placed on the first and eleventh frame. UT, ECT, PT confirmed that inner structure of the material (fittings, bushings, brackets, bolts, axels) was flawless. There were some traces of corrosion on the first frame fittings, but it was easily removed. Mechanical damages that have been detected are presented in the next figures, with location in the Fig.13 and mechanical irregularities on the left fitting and right front skin in Fig.14.

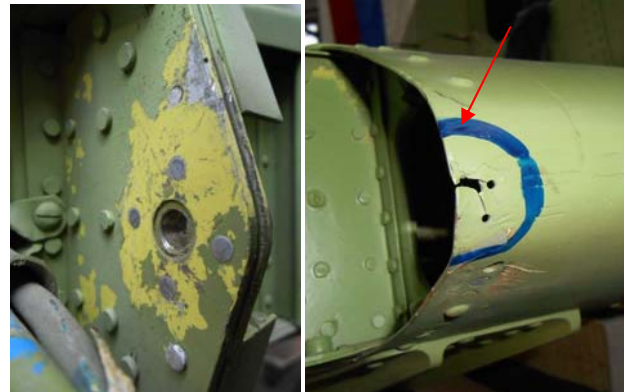
Figure 14. Left - mechanical damages of the fitting Right – right skin damages

After inspection, the report has been written. It includes the results of examined structure and the requirements for the mandatory repairs. The experts have confirmed, after control inspection of the structure, that all the necessary repairs are conducted in compliance with report requests. Consequently, life-cycle of the structure has been extended for 10 years.

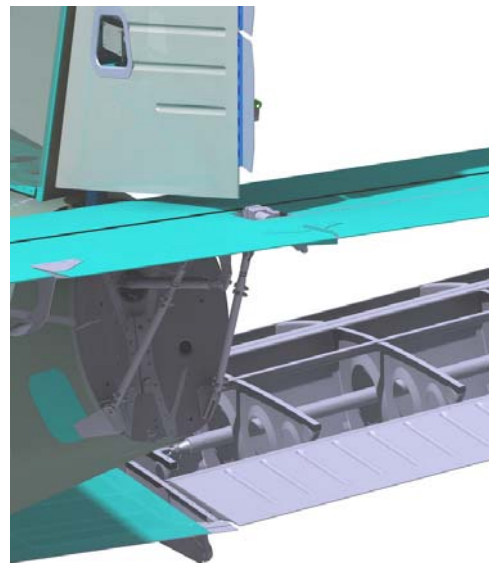
Figure 15. Unchanged structure of Sova aircraft

Structure revision consists of minimum changes on the wing and empennage (Fig.15), but central area of the fuselage is reinforced due to two additional passenger seats and enlarged cabin doors.

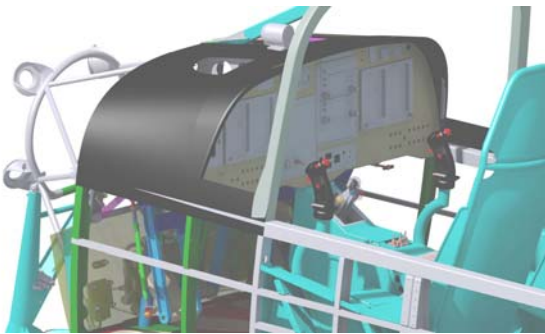
Figure 16. CAD model of redesigned cabin space

Main modification was performed in the cabin space (seats, instrument panels, controls, etc.). There is a new digital instrument panel, pilot sticks and engine controls (Fig.16); redesigned pilot seats area, with addition of central and side console which are also used as a support for pilot seats. Pilot seats can be set in six position, providing suitable accommodation for any pilot.

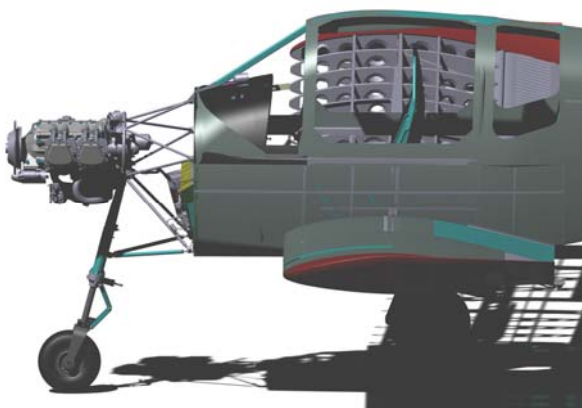
Changes, including reinforced structure and mass increase, consequently led to revision in a propulsion. New engine has been integrated, Lycoming IO-390-A1 B6 (max power 210 hp) paired with appropriate two blades Hartzell propeller. It improves aircraft maneuverability in comparison with former *Utva 75*. Engine mount was tested, and then slightly modified in accordance with the new engine (Fig.16).

Figure 16. CAD model front Sova aircraft section

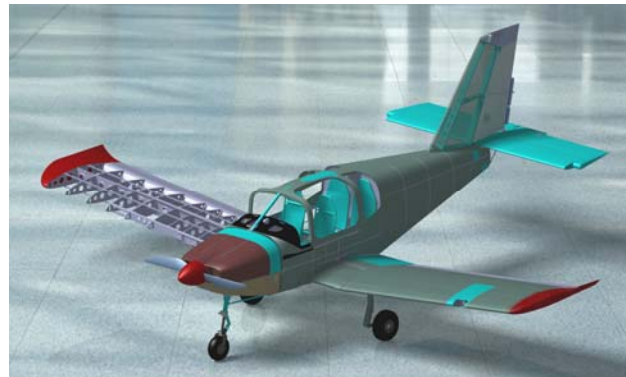
After inspection of the *Utva 75* structure, life-cycle extension has been confirmed. Conversion, as a choice of money-time saving solution, has been performed on the existing structure. Project included redesign of the central fuselage part, with emphasis on the cabin area modification. New control and propulsion systems are integrated. Whole project is supported by modern design software (CATIA V5) (Fig.17).

Figure 17. CAD model of Sova aircraft

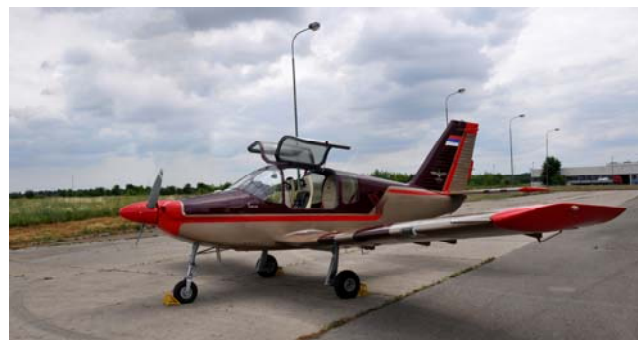
Sova (Utva 75 A41M), as a conversion of *Utva 75*, with modification of cockpit area, controls, propulsion will result in a new CS 23 certification (Certification Specification for Normal, Utility, Acrobatic and Commuter Category Airplanes).

Figure 18. Sova - Technical demonstrator
