Measurement and Analysis of Vibrations on the Helicopter Structure in Order to Detect Defects of Operating Elements

Slobodan Stupar[1]
Aleksandar Simonović[1]
Miroslav Jovanović[2]

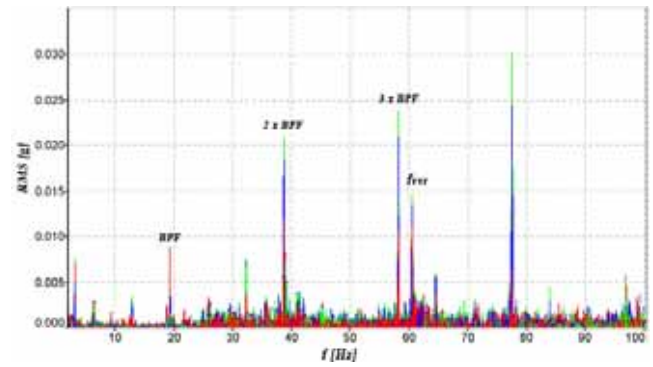
Figure 7. Vibration at specific locations in the cabin in the phase of acceleration

The flight test was conducted after 100 and 200 hours of operational service. After 100 hours, the change at frequency of 60.45 Hz was noticeable but it was lower about 6-7 % than the reference values of the vibration maps created from the first flight test. The results of testing after 200 hours were entirely different. The average FFT spectra from the second test (for channels 1, 2 and 3) are shown in Fig.7.

From these FFT spectra, from Fig.6 and Fig.7, it can be noticed that the biggest difference in amplitude levels is at a frequency of 60.45 Hz, which is an operational frequency of several helicopter elements. The percentage difference in the amplitude levels at a frequency of 60.45 Hz, between the adopted vibration maps and the second vibration check flight test, is presented in Table 3.

Comparing the vibration values in Table 3, it can be seen that the increase of all vibration amplitudes at a frequency of 60.45 Hz after 200 hours results in a potential fault in the part of the system operating at a given frequency, without being connected with a complex aerodynamic field. The slope shaft, the inter gear box, the horizontal shaft, the binder shaft of the tail shaft and the tail gear box are the transmission parts which operate at 60.45 Hz. The oil and hydraulic pumps were not considered because the fluid pressure is within the allowed range, the functions of system lubrication and hydraulic controls system are satisfied in whole operational range.

In accordance with the vibration theory, the transmission elements were subjected to measuring and analysis [8,9,10]. Since all these elements are located on the exterior of the Gazelle helicopter, it was decided to perform their visual inspection. After this inspection, the inter gear box was changed and the new vibration check flight test was performed. The results from the flight test with new inter gear box were analyzed and it was concluded that the amplitude levels of vibration of new gear box was on the level above of adopted vibration map for proper conditions, but below the vibration levels from test confirmed at 100 hours flight test with old inter gear box. These conditions of new inter gear box were adopted as correct for further operational service.
