Moisture Mapping of Aeronautical Museum Depot and Galleries by IR Thermography

The paper presents the results of moisture detection in the depot and galleries of the Aeronautical Museum in Belgrade. The moisture and changeable temperature conditions are the main causes for corrosion in historical buildings and museum artefacts. The main purpose of the tests was to determine these conditions in the museum where very important metal artefacts are exhibited and deposited, including the only surviving example of the Fiat G50 aircraft, by applying passive IR thermography. The advantages of thermography in a rapid and accurate detection of moisture in the walls, ceilings and floors of the museum are analysed. Active IR thermography is used for the determination of the composite structure and the characterisation of hidden corrosion in some parts of the Fiat G50 aircraft. The recorded thermograms indicate the damage due to corrosion in many parts examined in detail by radiography and the XRD method.

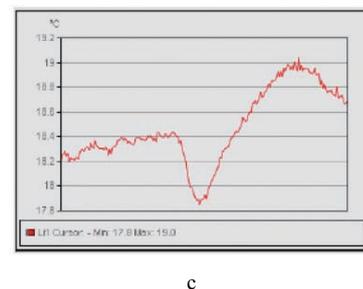
The presence of moisture is found in several places in the floor of the depot (Fig.8), on the ceiling and the walls (Figures 9 and 10b). The thermogram 9b next to the line tool has the area limited by isotherms. The diagram in Fig.9c shows that the temperature difference along the line tool is more than 1°C (1.3°C). The similar temperature distribution is on the line tool, Fig.10.

Figure10. Documentation for the detected moisture in the farthest right corner of the depot.
