The Aircraft Structural Elements Corrosion Study Using Strain Gauge Method and Pulse Video Thermography

Ljubiša Tomić¹⁾
Dalibor Jovanović²⁾
Stevan Jovičić²⁾
Radovan Karkalić³⁾
Goran Dikić³⁾

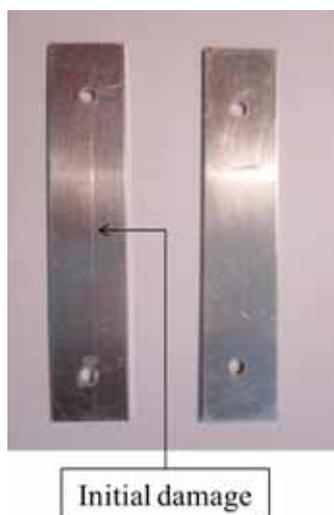
Testing was performed on ten bars, dimensions 20 mm x 100 mm x 1 mm. Nine bars were exposed to the influence of aggressive corrosive environment. Eight out of ten bars were exposed to the influence of static and dynamic load. Two bars were not exposed to the influence of any form of load and they were left outside the equipment for application of tensile force (one in room conditions, bar No.9, and one was exposed to the influence of salt fog, bar No.10). Four bars had a cut at the half of their length, representing an initial damage (Fig.1), 2 mm x 1 mm in size (bars marked 5 - 8).

Figure 1. Test bars prior to testing (left bar with the initial damage)

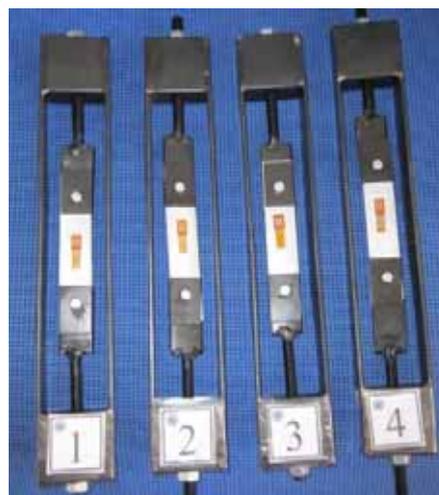
Figure 2. Test bars with strain gauge are set in the equipment for the application of tensile force

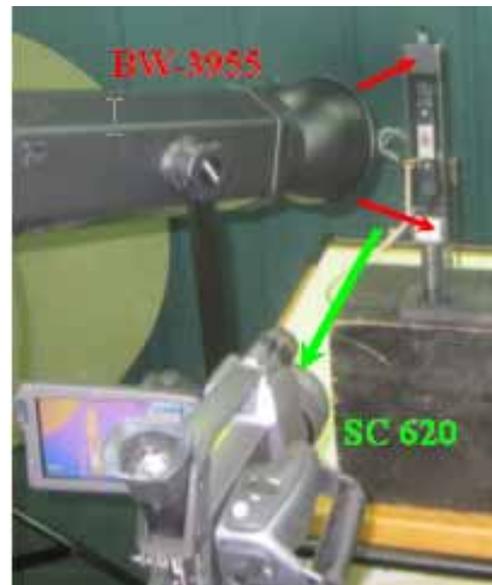
The experimental setup for recording of sequences of the test sample No.4, is shown in Fig.5. By using of the ThermoCAM Researcher™ software, the measuring lines can be positioned in the middle of the specimen thermogram, vertically and horizontally at the spots where the fracture appeared [3, 21-23]. For a more precise analysis of the temperature variations on the tested specimen surface and its link to the mechanical properties, the detailed analysis has been conducted along the lines.

Figure 5. Experiment setup for recording of sequences of the test sample No.4

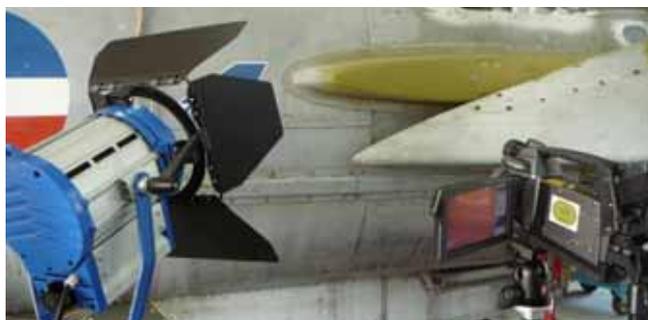
Figure 7. Testing of the tailplane-fuselage fillet at the root of the tailplane
